HONG KONG CEMETERY

CONSERVATION MANAGEMENT GUIDELINES

PART I – BUILT AND NATURAL HERITAGE

By Property Conservation Company Limited in association with Cinotech Consultants Limited and Ir. A J Cooper

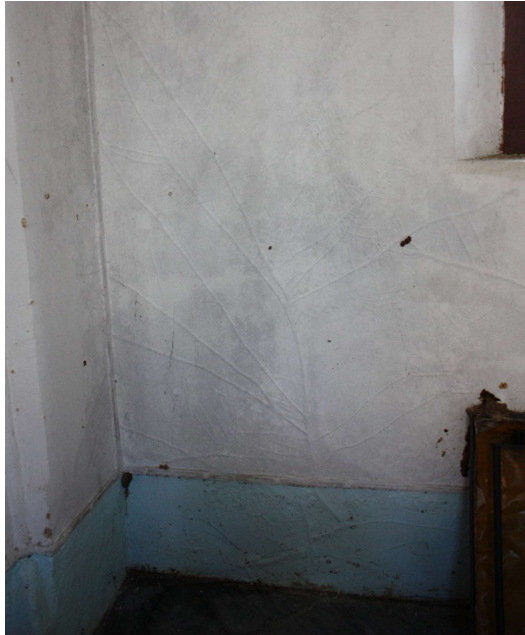
- 4.1.22. Despite the close attention of the FEHD management and maintenance officers, the building is deteriorating from lack of careful and timely attention, for example, vegetation roots are growing inside the walls. Although regular painting may hide superficial problems, the fundamental issues have not yet been addressed, such as termite damage and rising damp. Also, the adjoining toilet block and an external water stand pipe, cause serious damp ingress through the original external wall, which worsens the overall dampness within the building and consideration should be given to its demolition. During the preparing of this guidelines, signs of termites damage was visible to the doors.

FIGURE 4-24 Tree root inside the wall

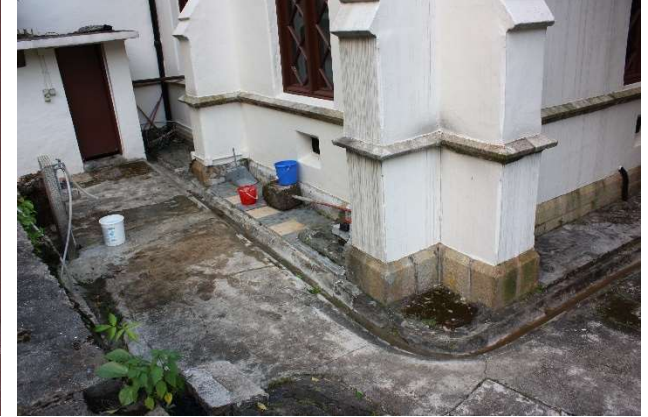
FIGURE 4-26 Use of water tap at the West side of the Chapel causes constant dampness to the historic wall

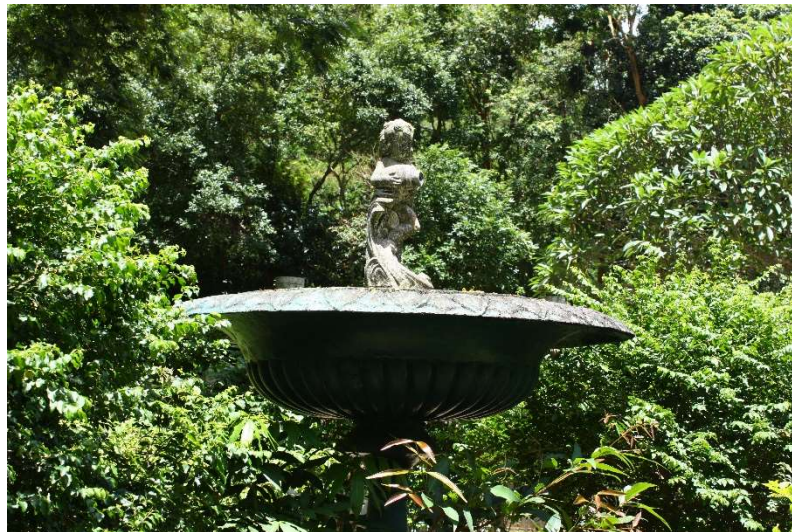
- 4.3.5. But, it is no longer able to function as a fountain due to water supply defects. Photos from 2012 (Figure 4-37) and 2016 (Figure 4-38) show the fast rate of growth of the shrubs which now obscure the historic feature.

FIGURE 4-37 Fountain in July 2012 (Property Conservation)

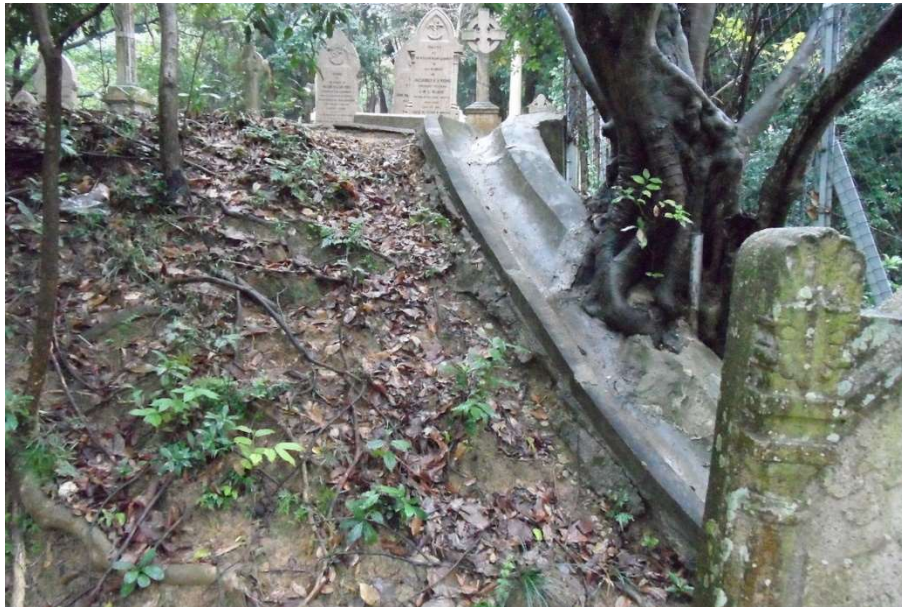
5.3.13. Many of the drainage channels are in poor condition (Figure 5-6 and Figure 5-7). They have deteriorated further in the last year. Broken channels let water into the soil and increase the likelihood of failure. Some appear to have been constructed using a very thin layer of mortar. They should be repaired as soon as possible.

FIGURE 5-5 Erosion of Soil and Ineffective Drainage Channel

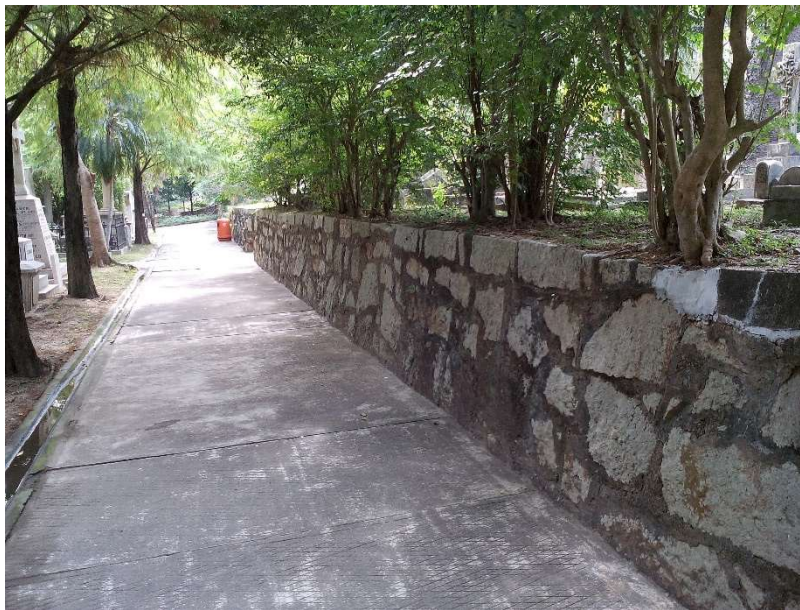
FIGURE 5-11

- 5.4.11. The first feature is a random rubble wall, about 1.3m high, which is in good condition. This is probably one of the earliest walls constructed in the cemetery, though the mortar infill almost certainly dates from much later (Figure 5-11). There are several trees growing near the crest; at present they have not caused damage to the wall but the wall should be monitored and action taken if any cracking is noticed in future.

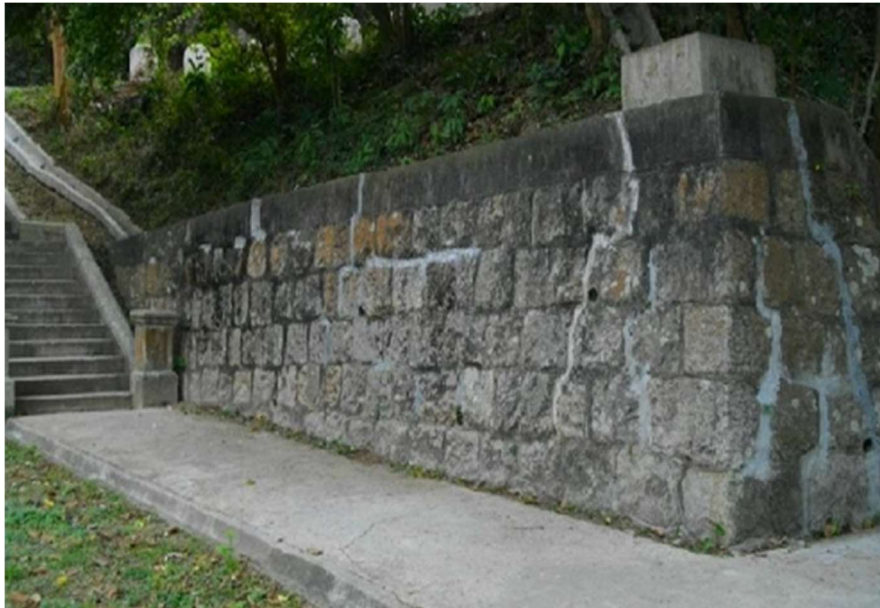
- 5.5.17. When a wall is an external L-shape, as in this case, the rotation cannot happen without something giving. From Figure 5-19, it can be seen that the corner section has remained in place but shear cracks have opened between the straight sections on either side and the corner section. This is quite normal and further movement would not be expected. The cracks have been repointed, but the workmanship is poor.

FIGURE 5-19 Wall and cut slope of CR1478

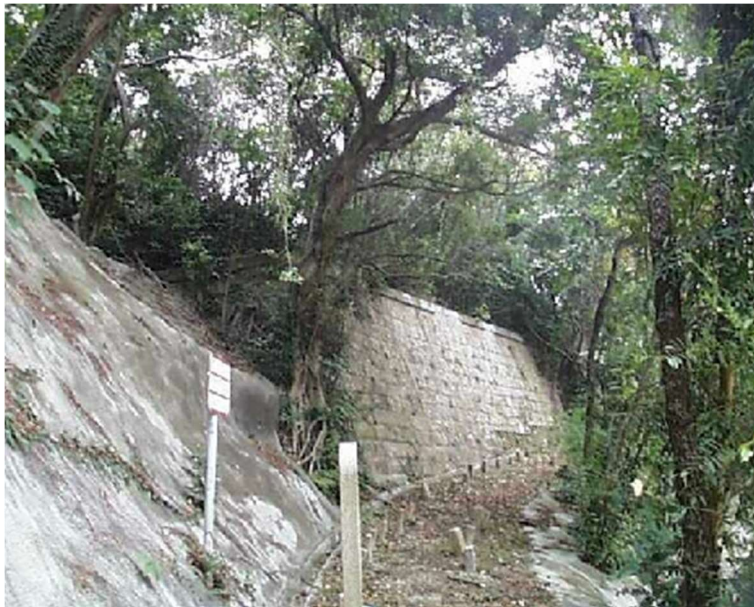
- 5.5.19. This feature is a 4.2 m high dressed block wall, with a 25° vegetated cut slope above it. The slope is approximately 2m high. The first photo in the Stage 1 Report in the SIS shows the wall (see Figure 5-20). It also shows a sizeable chunamed cut slope closer to the camera position but, surprisingly, no mention of this slope is made in the SIS.
- 5.5.20. The wall is in good condition and has drainage channels at both the crest and the base so there is no reason to take further action at present, apart from regular maintenance. This would consist of removing vegetation from between the blocks in the wall, repointing if necessary and ensuring that drainage channels are clear of debris before the rainy season.

FIGURE 5-20 Wall of CR1877 and Unreferenced Slope

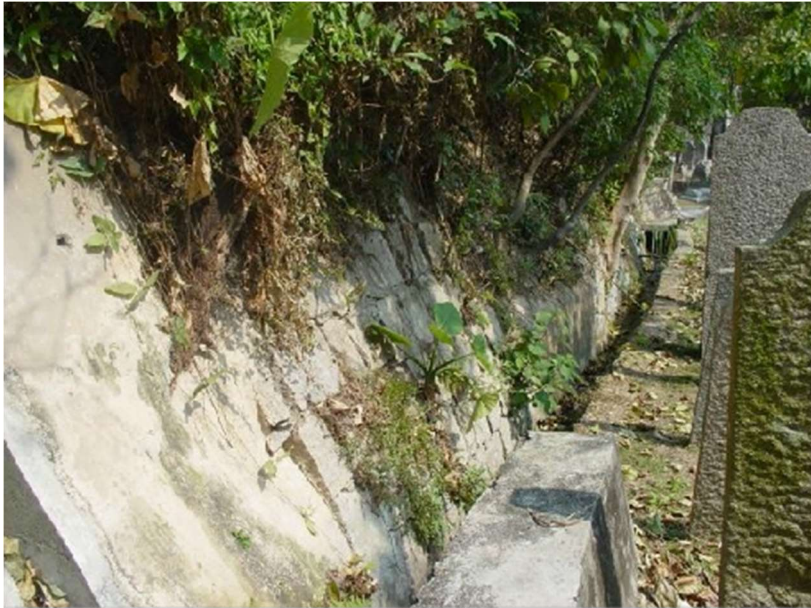
5.5.30. The slope appears to be in good condition but it is heavily vegetated which makes it difficult to assess properly.

FIGURE 5-23 Cut Slope 11SW-D C 2149

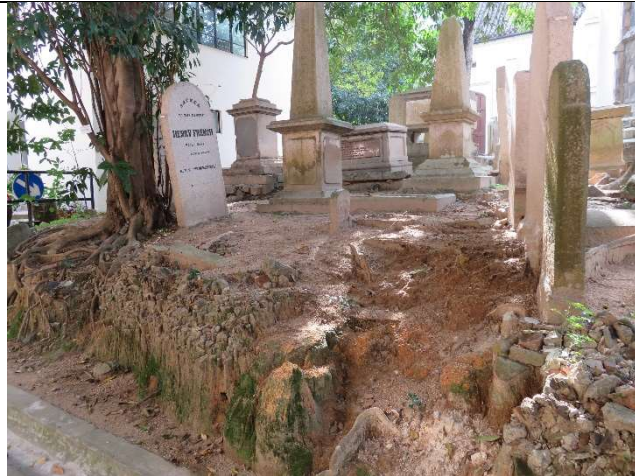
Bare soil requiring turbing to prevent erosion

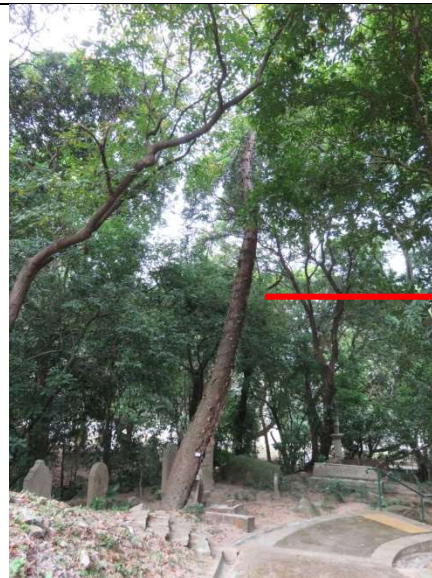
Dead tree with leaked sap, growing next to footpath

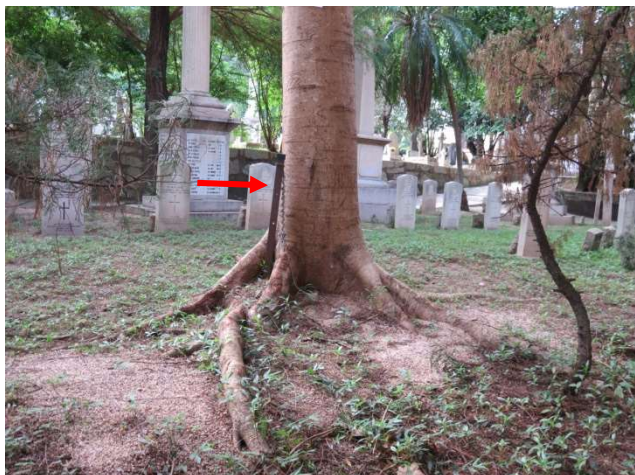
Metal bar damaging tree roots
