Conservation Management Plan
for
Hong Kong Museum of Medical Sciences
at No. 2 Caine Lane, Mid-Levels,
Sheung Wan, Hong Kong.

By Spence Robinson Limited

Oct 2024

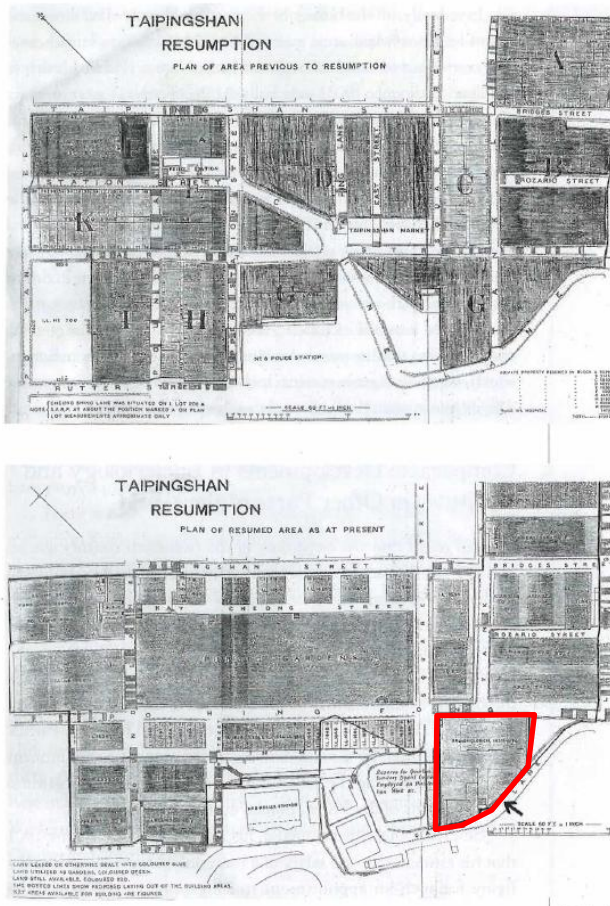
Fig. 22. Plan of Tai Ping Shan area before(top) and after(bottom) resumption. The location of BI on Caine Lane is highlighted in red. (Source: Hong Kong Museum of Medical Sciences Society. 2006. *Plague, SARS and the Story of Medicine in Hong Kong*, edited by Arthur Starling et al., p27. Hong Kong University Press. p155)

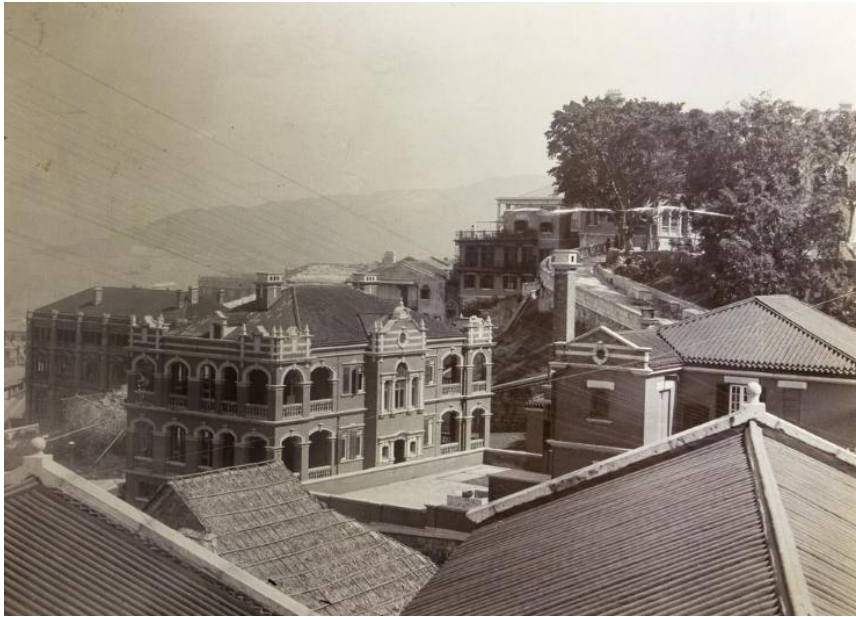
“...Balconies extend along the whole of the north front on the ground and upper floors and there are verandahs on the east, south and west fronts...”

Fig. 24. Old photo of Main Building, facing the courtyard of the Animal House. 1906-1910.

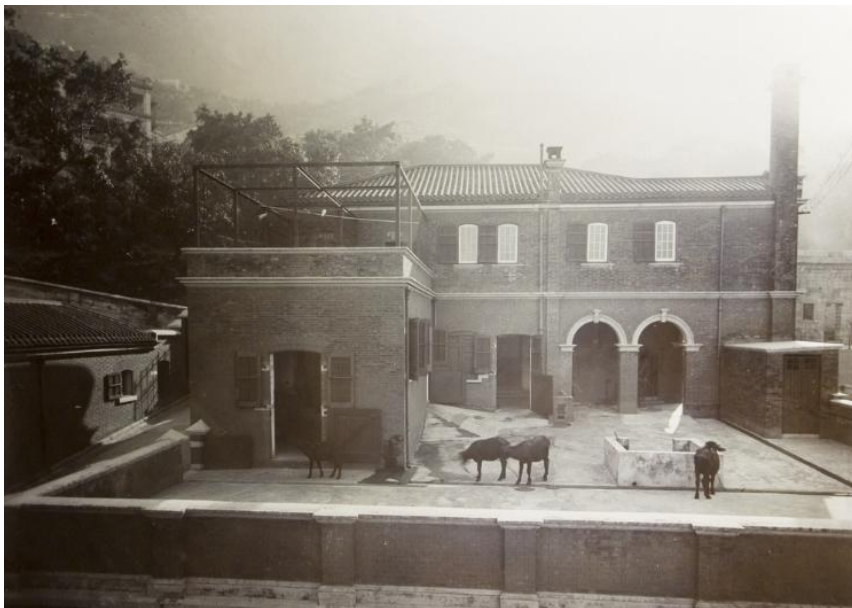
“...One of the subsidiary blocks (a one-storied building) affords accommodation for 11 Chinese attendants, with kitchen, &c., whilst the other (a two-storied building) contains a stable (4 stalls and 2 loose boxes); houses for 5 cattle and 8 calves; 2 sheep-pens and suitable accommodation for monkeys, fowls, rats, mice, guinea pigs and rabbits. There is also a room for 4 Chinese attendants, a doctor’s room, a corn store and a fodder store...”

Fig. 25. Photo of the Animal House. 1906-1910.

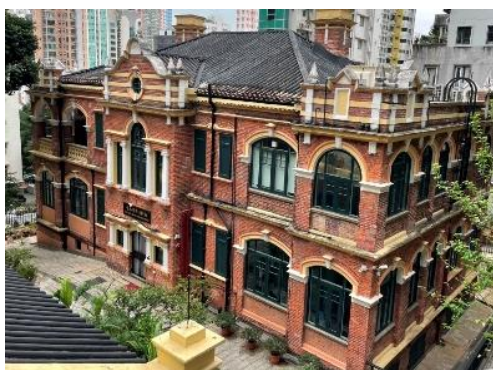
Fig. 29. Red brick external wall structural with double-pan-double-roll tiled pitched roof.

“All the buildings are of red brick, built in lime mortar and pointed externally in cement mortar... The roofs are covered with double pan and roll tiling, on timber purlins and principals...” (Refer to Fig. 29 and 30)

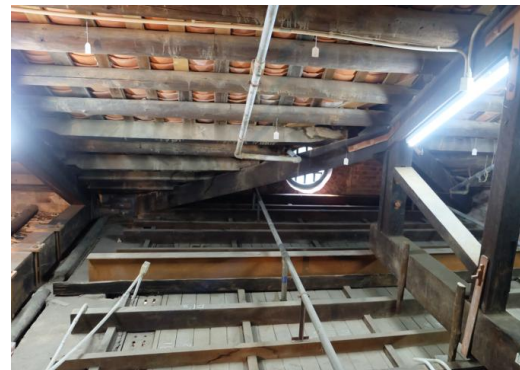
Fig.30. pan and roll tiles sitting on timber purlin and principals.

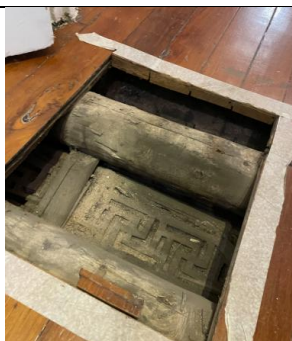
Fig. 31. timber joists under the teak floor.

“...the remaining apartments on the upper floor have teak floors supported on China fir joists.” (Refer to Fig. 31)

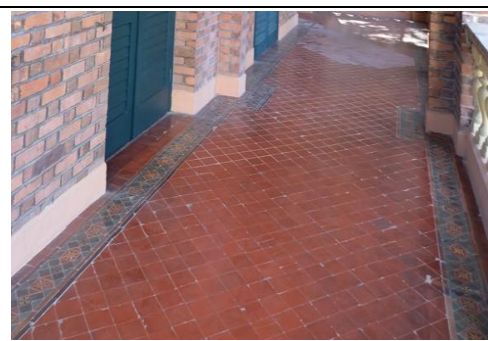
Fig. 32. Encaustic tiles flooring at the verandahs.

“...The two laboratories and all other apartments on the ground floor, including verandahs, &c., and the 2 laboratories and verandahs on upper floor have floors of cement concrete supported on rolled joists and covered with encaustic tiles.” (Refer to Fig. 32)

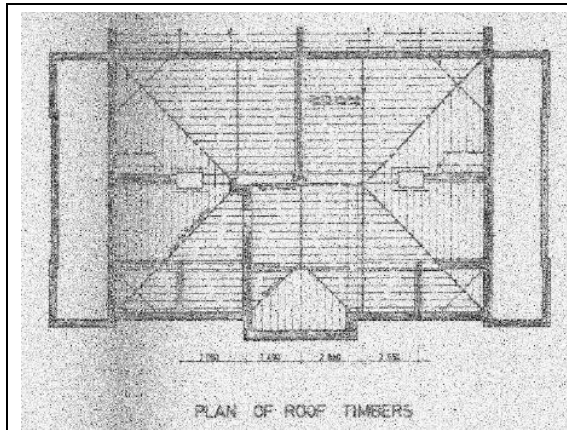
Fig. 33. Plan of roof timbers
(Source: Arch SD Maintenance Branch)

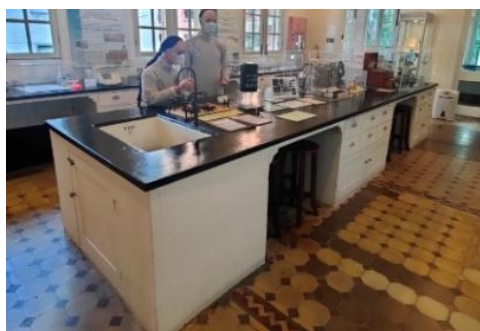
Fig. 37.

“ They consist of long wall benches with teal tops and fitted with sinks; large centre tables, also fitted with sinks; drawers, cupboard &c. A fume cupboard is also provided...”

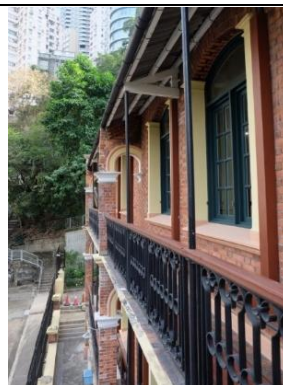
Fig. 38.

“The windows of the laboratories, which are placed in the north front, are fixed and glazed with plate glass, the balconies affording access for cleaning their outside surfaces...”

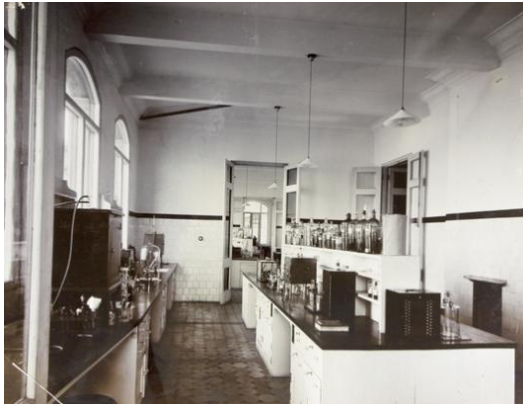
Fig. 39.

“Double doors are provided to all openings into the laboratories. one door being glazed and the other filled in with mosquito-proof wire gauze.”

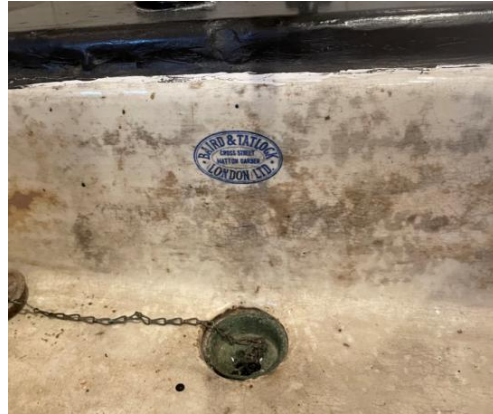
Fig. 40.

The sinks with trademark of Baird & Tatlock (Cross Street, Hatton Garden, London) Ltd still found in BI.

Baird & Tatlock (London) Ltd was established in 1881. It cannot be confirmed that the sinks are the originals from 1906 but they should be one of the old features in the laboratory.

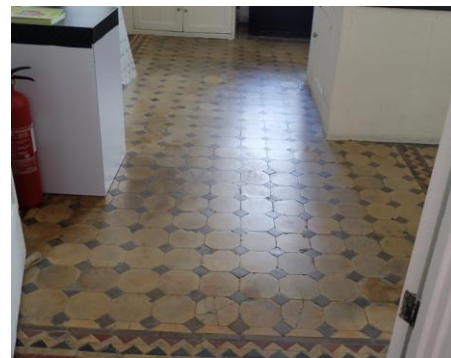
Fig. 41. & 42.

“...the 2 laboratories and verandahs on upper floor have floors of cement concrete supported on rolled joists and covered with encaustic tiles...”

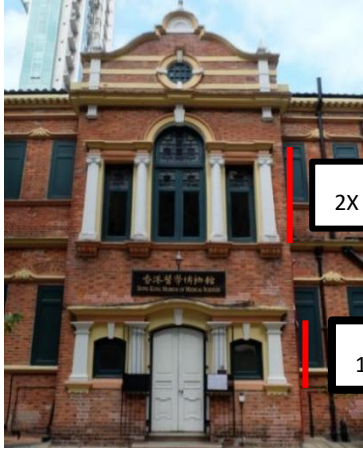
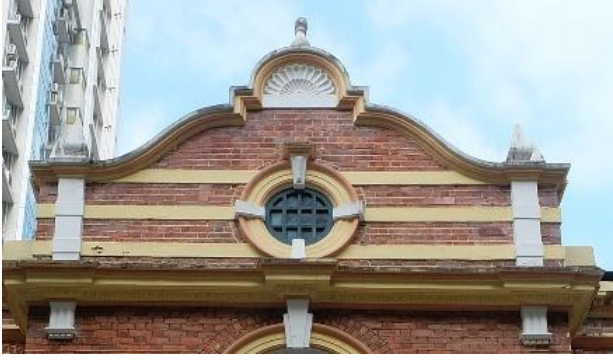
<p>Fig. 45. Edwardian style distinguishable protruding main entrance portal</p>	<p>Fig. 46. Dutch gable wall in curve shape with round window, pilasters and short strips</p>

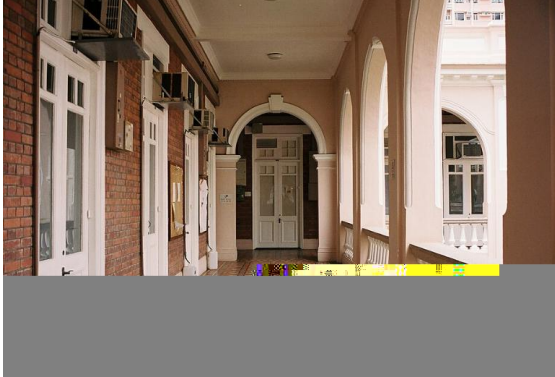
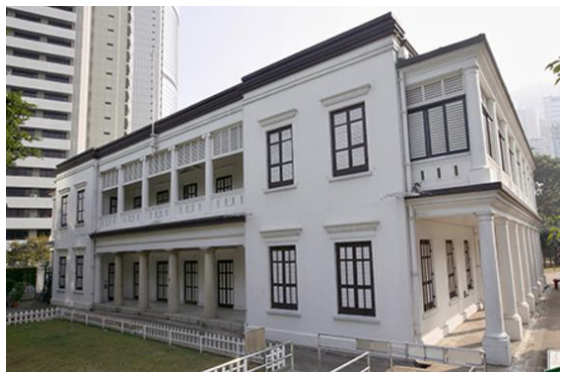
<p>Fig. 58. Flagstaff House with verandah and louvered shutter windows for shading. (Built in 1846) (Source: AMO website. Declared monuments in Hong Kong- Hong Kong Island. Last modified Dec 2021.)</p>	<p>Fig. 59. Verandah at the Main Building of the University of Hong Kong. (Built in 1910) (Source: Wikimedia Commons."The inside of The University of Hong Kong Main Building corridor". CC BY-SA 3.0.)</p>

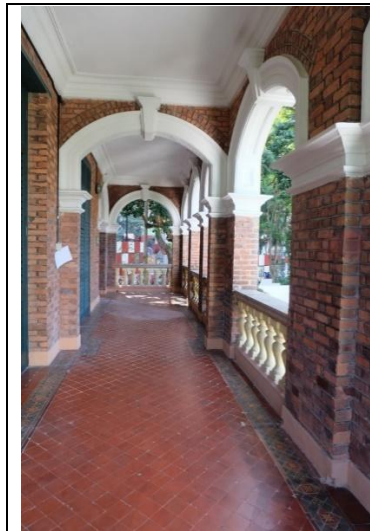
Fig. 60. Verandah at the BI with arch opening and balustrades, beautiful encaustic tiles in staggered pattern in the field with borders at the verandahs.

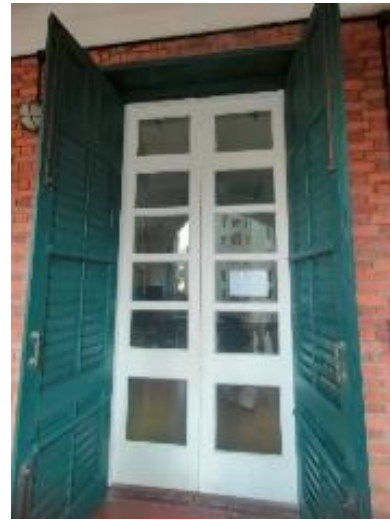
Fig. 61. Laboratory rooms with louvred shutter windows toward the verandahs. The tilt rods of the shutters control the level of openness. Door stays to fix the louvred shutter aside to allow no blockage of natural light while full open is necessary.

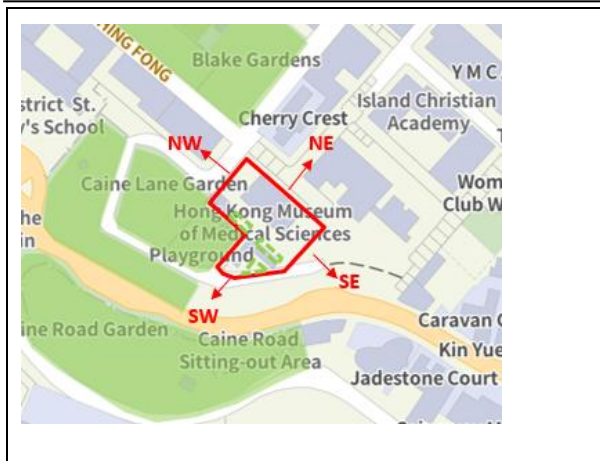
Fig. 62. Orientation was carefully planned to allow sufficient illumination to the laboratories.

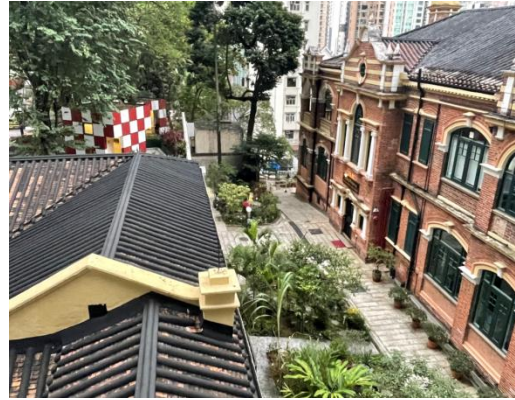
Fig. 63. Main Building is the highest in the Compound and allows sunlight to enter from the main façade side without obstruction.

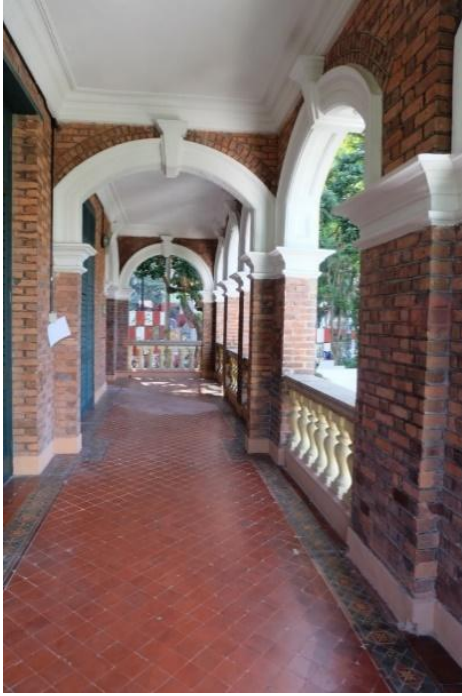
Fig. 66.
Verandah and large arch opening to allow good ventilation

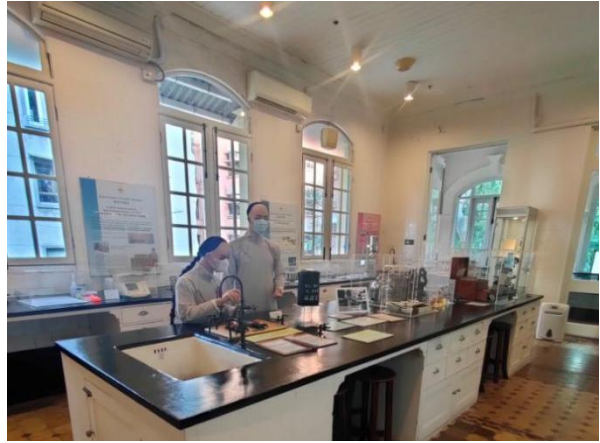
Fig. 67.
Large (about full height) opening windows and doors to allow good ventilation

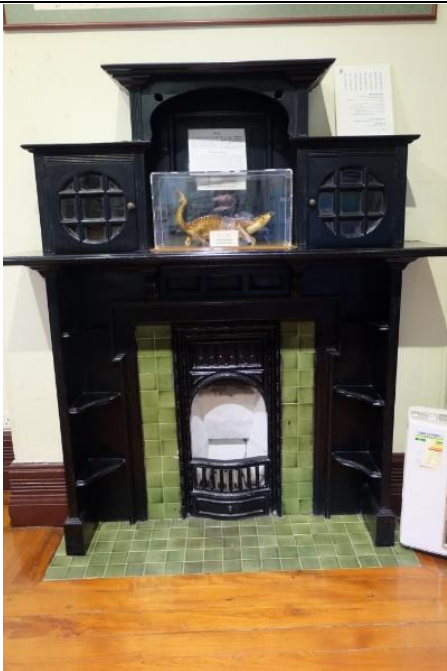
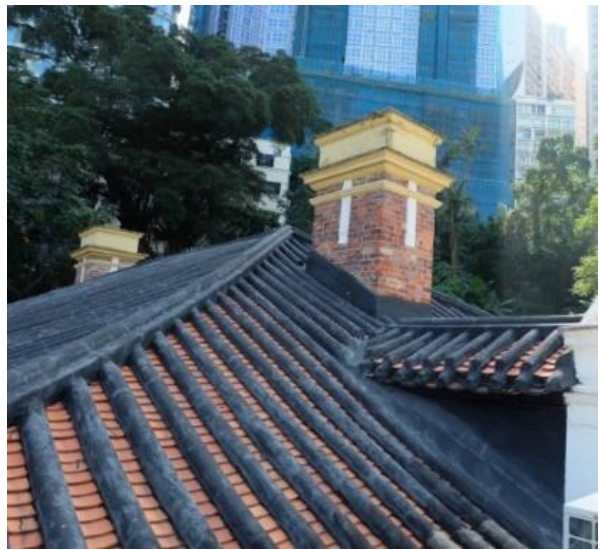
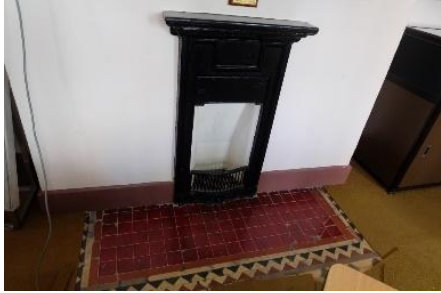
<p>Fig. 68. Fireplaces at laboratories and other function rooms for comfort</p>	<p>Fig. 69. Chimneys at the roof allow cross ventilation</p>

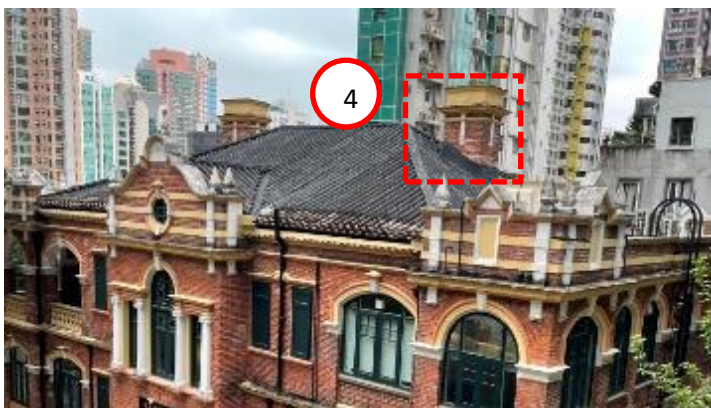
1906-10	2023
1. Verandah at the G/F facing NW	Open verandah, with balustrade and window sills above balustrades	Enclosed verandah with glazed windows, short wall below windows
2. Verandah at the G/F and 1/F facing SW	Open verandah, with balustrade and window sills above balustrades	Enclosed verandah with glass windows, short wall below windows
3. Name plaque	No name plaque above entrance door	Name plaque above entrance door
4. Chimney stack	Three flue apertures at the top	No flue apertures in elevation

Fig. 72 - 73. Main Building in 2023.

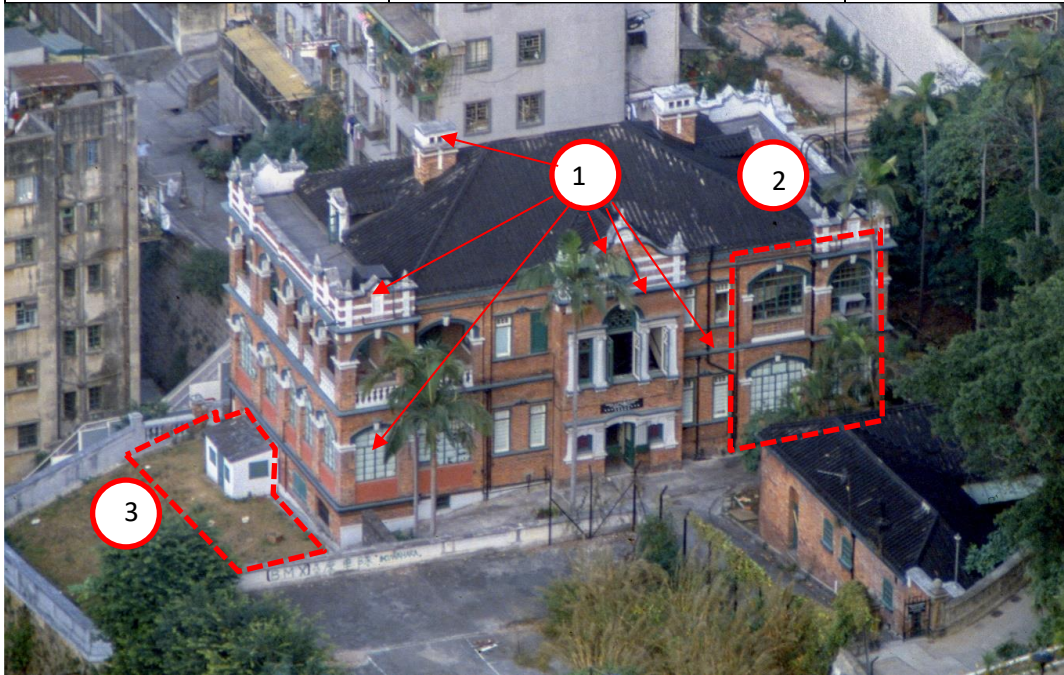
1980s	2023
1. Colour of the decorative mouldings, cornice, arch, window sill, balustrade and chimney stack	Grey and white for decorative mouldings, cornice, arch and chimney stack, white for balustrade and pink for low walls	Yellow and pink for decorative mouldings, cornice and arch, yellow for balustrade and chimney stack
2. Window pattern facing SW	Different window frame	Different window frame
3. Open area facing NW	Grassland with attached small house to the NW of Main Block, no public access	Cement walkway with plants

Fig. 74. Main Building in 1980s. (Source: Courtesy of Mr. Andrew Tse, for use of HKMMS in the CMP only)

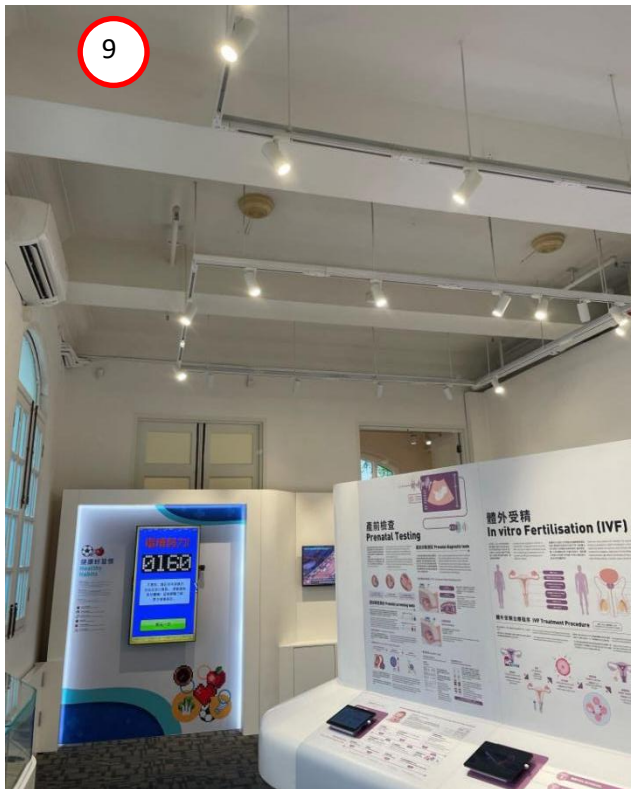
9. Structural beams at the ceiling as part of the structural system of the building

Fig. 91 (Top). Photo of the laboratory in 1906-1910 (Source: 'Historical Photographs of China', University of Bristol (CC BY_NC_ND 4.0)); Fig. 92. (Bottom) Exhibition area at G/F in 2023.

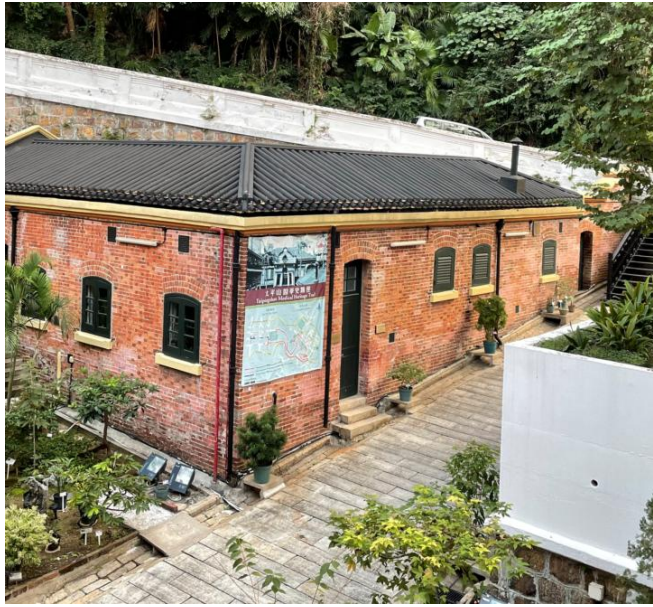
<p>Fig. 93. Photo of Staff Quarters in the 1906-10 when the animal house still exists. (Source: 'Historical Photographs of China', University of Bristol (CC BY_NC_ND 4.0))</p>	<p>Fig. 94. Photo of the Staff Quarters (now named Annex Block) in 2023. Brick external wall, tiled pitch roof, segmental arch over window, louvered shutter, window sill, service channel and location of side door remain unchanged.</p>
Photo in 1980s	Photo in 2023

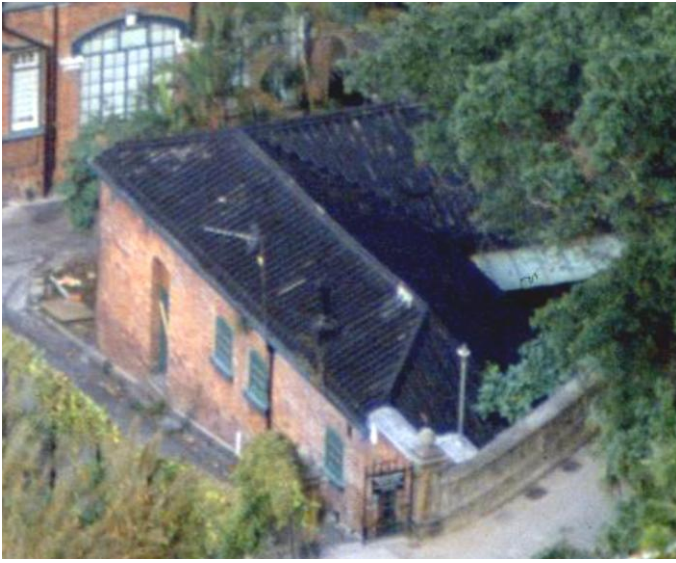
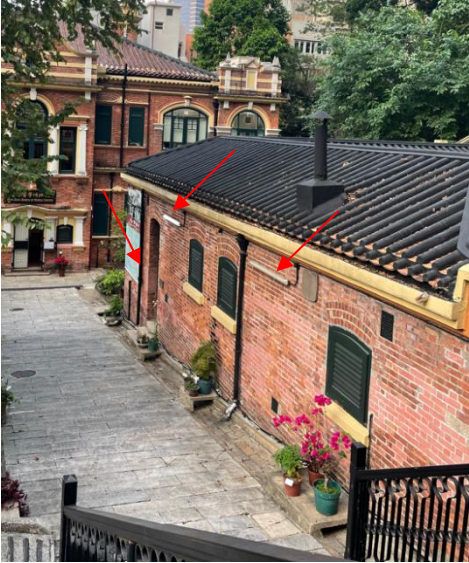
<p>Fig. 95. Old photo at around 1980s. (Source: Courtesy of Mr. Andrew Tse, for use of HKMMS in the CMP only)</p>	<p>Fig. 96. Remain highly intact, only introduction of building services (downpipe, light fixings are found)</p>

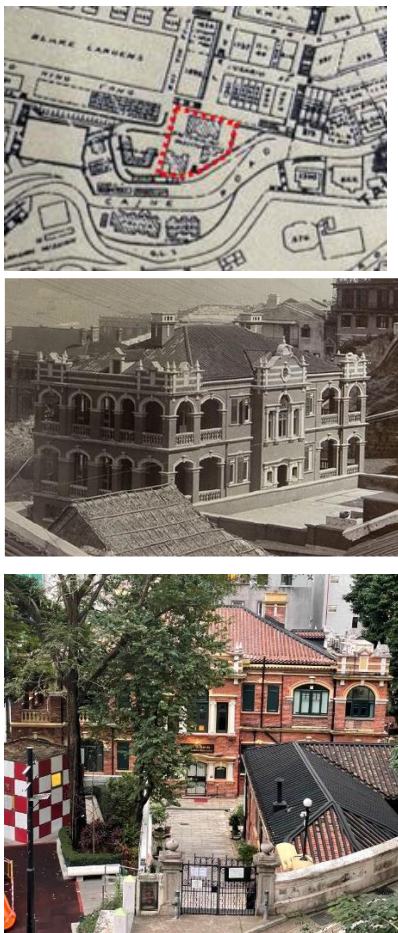
<p>S-6</p>	<p>Block disposition</p>	<p>-Higer Main Block and lower subsidiary block -Main Building with subsidiary block(s) for supplementary services</p>

<p>Moderate- Historic and Architectural Significances</p> <p>The compound consists of Main Building and Staff Quarters, which were common block disposition for the government building due to limited public transportation before mid-19th C.</p> <p>Staff Quarters, now named Annex Block, serves as another activities room & meeting room in supporting the museum activities. It has retained the role as a subsidiary block of the Main Building since it was built.</p> <p>Lower subsidiary block allows the appreciation of the Main Building main façade from Caine Lane.</p>
<p>S-7</p>	<p>Micro-climate</p>	<p>-Level different of buildings (3-storey Main Building and 1-storey Annex Block) -Open space /pathway at the sides of Main Building and Annex Block -Pathways within the BI compound in cross directions</p>

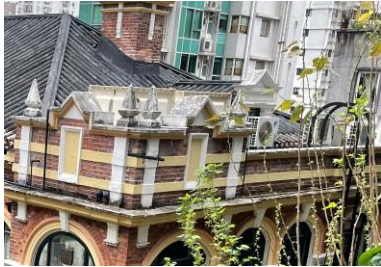
No	Elements	Character	Photos	Level of Significance
M-1	Roof top decoration	-Obelisk-shaped finials at the roof, with pilasters and shorts strip on brick wall -Symmetrical

Exceptional -Architectural Significance A rare example of Edwardian architecture in Hong Kong with arts and crafts influence. The location of additional AC and water tank facilities should be reviewed if the current use of the compound is altered.
M-2	Flat roof at the rooftop	- Flat roofs at two sides above verandahs with low brick parapet -Symmetrical

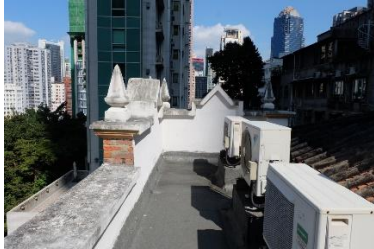
Moderate -Architectural Significance It is believed flat roofs are part of the building design as well as for maintenance access purposes.
M-3	Dormer at the roof	-Dormer doors at two sides -Pediment at the top -Door opening

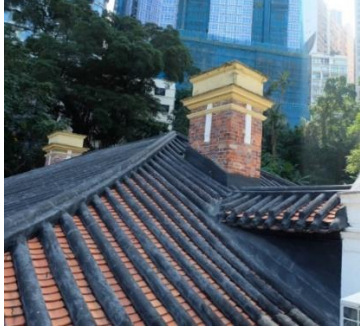
<p>M-4</p>	<p>Main hipped pitch roof</p>	<ul style="list-style-type: none"> -Hipped pitched roof -Chinese double-roll-double-pan roof system with use of wu-yin -Symmetrical

<p>High-Architectural Significance</p> <p>The western hipped-pitched roof in use of Chinese double-pan-double-roll tiles system and wu-yin use, that showcase the adaption of Western architecture with local material, craftsmanship for adaptation of local climate and culture in colonial style building.</p>
<p>M-5</p>	<p>Red brick chimney</p>	<ul style="list-style-type: none"> -Red brick chimney stack -Symmetrical -Decorative moulding and pattern

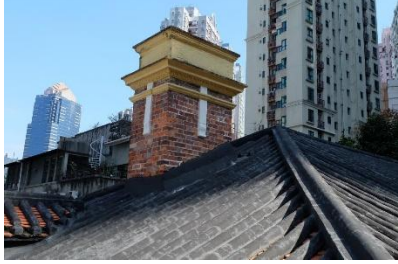
<p>High-Architectural Significance</p> <p>Chimney is a typical feature of western pitched roof. It allows cross ventilation of the building and the bacteriological laboratories. It also provides a lively and movable skyline for the architecture.</p> <p>According to old BI photo (early time and around 1980s), there were three flue apertures at the top of the chimney stack. Now they are blocked and may be for the avoid of falling water, dust and release of cold air after installation of air-conditioners.</p> <p>Today, mechanical ventilation is so commonly in-use. Also, the awareness of environmental protection (pollution) is high. Fireplaces no longer allow and have necessities to serve its original warm-up and ventilation function.</p>

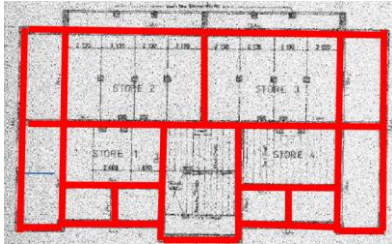
<p style="text-align: center;">Layout of the brick walls</p>	<p>High- Architectural, Historical and Social Significance</p> <p>A rare example of Edwardian architecture in Hong Kong with arts and crafts influence. Exposed bricks were used instead of rendered surface. It is the true expression of material in Art and Crafts movement.</p> <p>The different colour and shape of the Flemish bond red bricks and mortar joints (some recessed and some not) show that the brick walls have undergone many repair works and no proof of any part of the external brick wall is original.</p> <p>While, the layout of the structural brick walls should be low intact and much of the original.</p>
M-8	Classical Features	Ironic column brick arch, entablature, cornice, mouldings

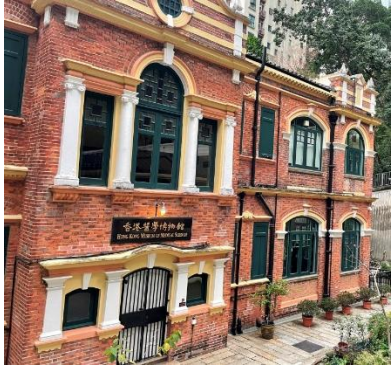
<p>High - Architectural Significance</p> <p>The classical features have functional and aesthetic value. Cornice and moulding at the façade hid the rainwater marks. The horizontal lines also direct our eyebrow to move up and down along the façade in a more lively way.</p> <p>There are decorative features of different styles in use, such as classical ironic column at the main façade, Romanesque brick square piers. They reflected the architectural style is no longer highly regulated at the early 20th C.</p> <p>The features are moderate to low in significance solely but high in significance with the red brick external wall to create the ambience as a whole.</p>

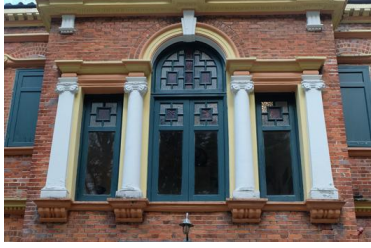
<p>M-11</p>	<p>Palladian windows</p>	<p>-In stained glass with Chinese motifs -Central location of the protrude front entry portal</p>

<p>High- Architectural Significance</p> <p>The good combination of western architecture style with Chinese style motif. It showcases the wisdom of adaptation of local culture to western architectural features in colonial style buildings.</p> <p>SE facing stained-glass window with Chinese motif allow colorful sun ray stream into the main entrance hall, and leading visitors to walk upstairs.</p> <p>According to old photos, these were openable windows. They were good for air ventilation in the old days. Now, as the mechanical ventilation has introduced, and the rooms no longer served as bacteriological</p>

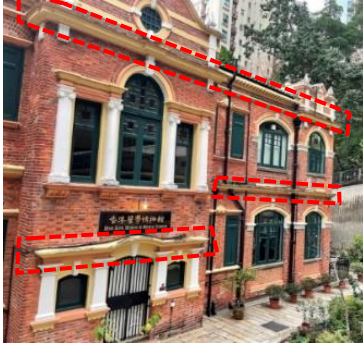
/pathological/medical laboratories, their role on air ventilation become low.
M-12	Cornice, frieze, architrave and other decorative moulding band (4 faces)	-Cornice, frieze, architrave and other decorative moulding band (4 faces)

<p>Moderate - Architectural Significance</p> <p>Cornice, frieze, architrave and other decorative moulding bands form the whole of the facades design which are important features of western architecture. The levels of horizontal lines direct our eyebrow to move up and down along the façade in a more lively way.</p> <p>Cornice, moulding serve not only decorative purpose but also minimized water marks on facades.</p>
M-13	Roof drainage system	-Overhanging gutter system - Cast iron rainwater downpipe with hopper

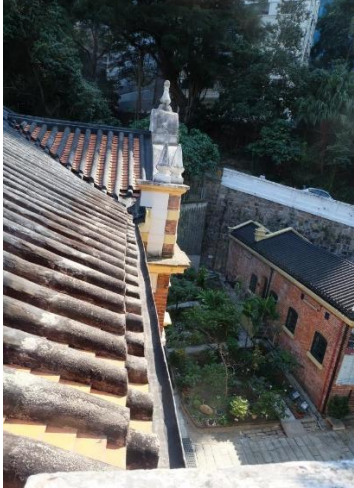
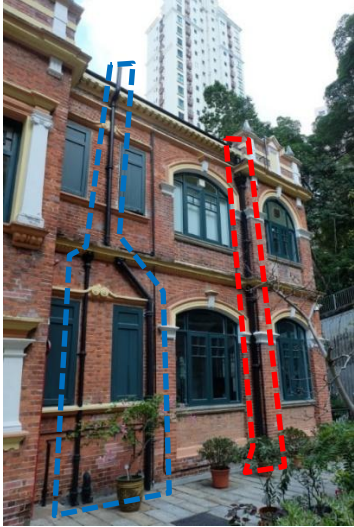
<p>Moderate - Architectural Significance</p> <p>Downpipes were found in the old photo in early BI. It is believed the gutter and downpipe drainage system is the original.</p> <p>Rainwater from the NE and SW roof discharges directly to their gutter. SE and NW roofs fall from the pitched roof to the flat roof. They finally discharge from the RWP at the NE and SW façades.</p> <p>Some downpipes are believed to be later addition (no existing in old photo of early BI) and they are located at quite dominated location of the front façade.</p> <p>Location of them can be reviewed to the least obstructive location if the current use altered.</p> <div style="display: flex; justify-content: space-around; margin-top: 10px;"> <div style="border: 1px dashed red; width: 40px; height: 20px; display: inline-block;"></div> <div style="border: 1px solid black; padding: 2px;">Piping believed to be original</div> </div> <div style="display: flex; justify-content: space-around; margin-top: 10px;"> <div style="border: 1px dashed blue; width: 40px; height: 20px; display: inline-block;"></div> <div style="border: 1px solid black; padding: 2px;">Piping believed to be later addition</div> </div>

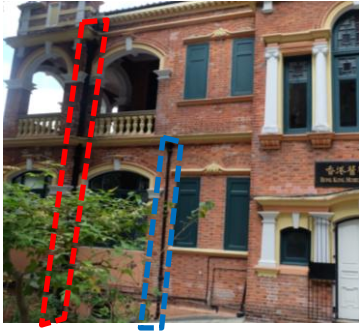
<p>Overhanging gutter around the roof is highlighted in blue</p>	
<p>M-14</p>	<p>Arcade at the 1/f and G/F</p>	<ul style="list-style-type: none"> -Large contiguous brick arch openings -Key stone -Brick piers

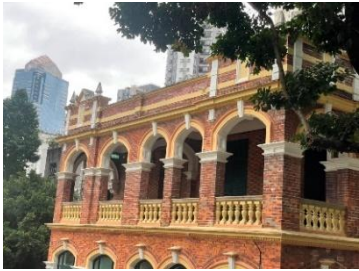
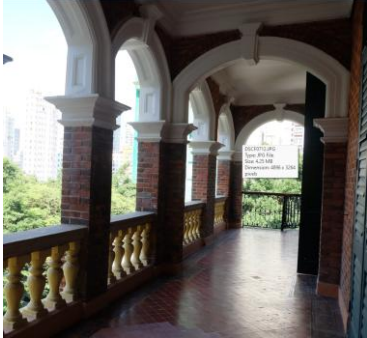
<p>High -Architectural Significance</p> <p>Brick arcades have long history in western architecture. The brick arcade at the verandah is an iconic colonial architecture design. It serves both functional and aesthetic value. Large arch openings allow good ventilation of the laboratories and the building.</p> <p>The arch openings were enclosed in 1930 for the housed of Malaria Bureau and other unknow reasons, and the architectural significance of the Main Building is highly affected. Restoration of the open arcades can be reviewed and considered if the current use is altered.</p>

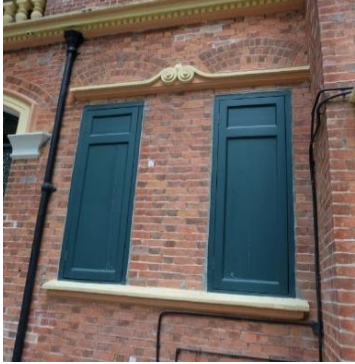
<p>-Timber external window -Glazed internal window -Window frame</p>

<p>3 panels</p> <p>1 panel</p> <p>Like a louvered shutter with central control</p> <p>(Photo of early BI)</p>	<p>Low - Architectural Significance</p> <p>Old photo of early BI shows that the design of glazed window was different from the existing. Restore to the original appearance to be considered.</p> <p>The existing timber windows look different from the early louvered shutter design. Restore to original design to be considered.</p> <p>These rooms are toilets nowadays, openable windows would be more suitable for better hygienic control.</p>
<p>M-17</p>	<p>Window at B/F of SW facade</p>	<p>Window opening</p>

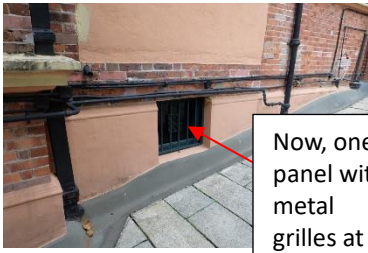
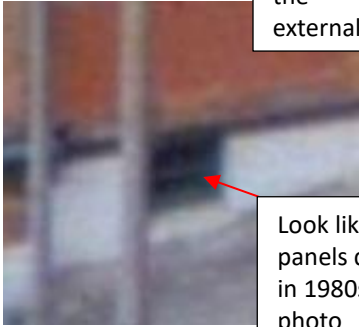
<p>Now, one panel with metal grilles at the external</p> <p>Look like 4 panels design in 1980s photo</p> <p>(photo in 1980s)</p>	<p>Low - Architectural Significance</p> <p>Ventilation needs for the B/F. Window opening should retain as it is.</p> <p>The existing timber framed glass window may not be the original with installation of a ventilation fan nowadays. It is also different from the photo taken in 1980s. But whether the WWII design is original, there is not enough evidence to confirm.</p>

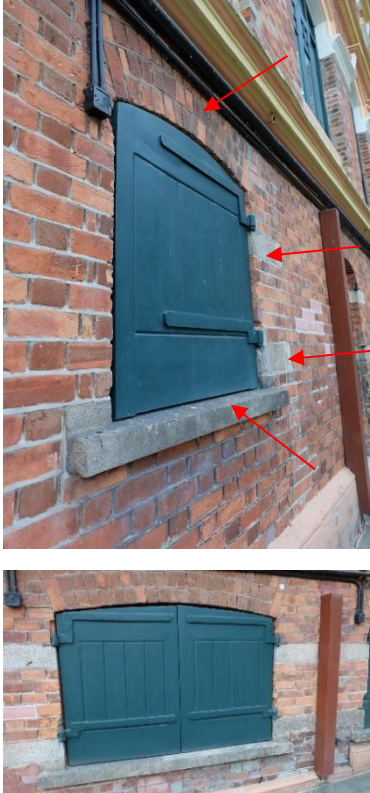
<p>Moderate - Architectural Significance</p> <p>The refrigerator, incubating room, heating chamber and dark room were located in the basement. Temperature and humidity control were important for vaccine storage at the time while vaccine production was one of the keys and long-lasting contributions of the BI-PI. Therefore, the windows are comparatively small at the B/F then G/F and 1/F. That reflects the significance of bacteriological institute design.</p> <p>Based on site inspection, the window openings, brick arch, window sill and the adjacent stone for window installation are aligned with each other and can consider the original design.</p>

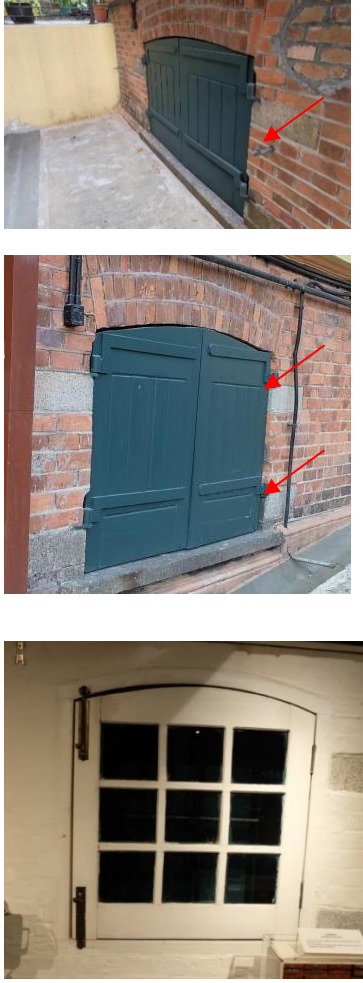
<p>-External timber window facing outward with associated window frame, hinges, tie-backs and stays -Internal glazed window open inward with associated window frame, hinges and locks</p>

<p>Low - Architectural Significance</p> <p>Based on the site evidence and the usage, it is believed that the external windows at the basement are very likely double layer for better environment and security control. The external window and internal window should open outward and inward respectively, with associated ironmongeries such as hinges, tie-back, stays and locks.</p> <p>The windows design record in 1992 elevation prepared by Maintenance Branch ArchSD (below) are quite different from existing design. Therefore, the design of the windows are unknown and can be considered altered when replacement works necessary.</p>

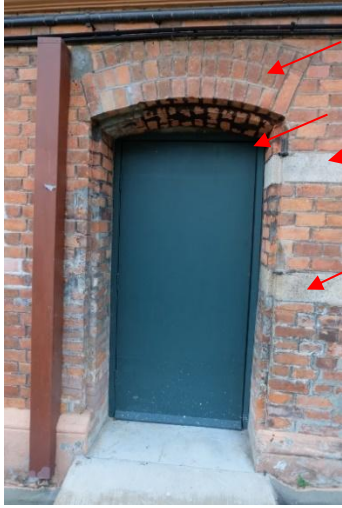
<p>M-19</p>	<p>Door at the basement</p>	<p>-Door opening at existing location and size -brick arch at the top and -Rectangle-shaped stone at the side(s) of window with hinge. They allow fixing of the windows -Timber door located at the inter end of the arch for better shield</p>

<p>Moderate - Architectural Significance</p> <p>Brick arch serves as a shield. Door locates at the end of brick arch to minimize the rainwater fallen-in.</p>

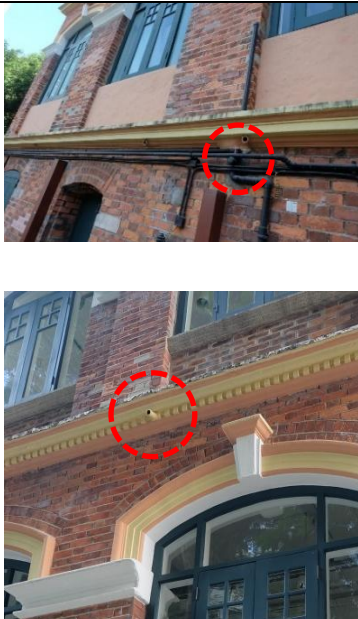
<p>Moderate - Architectural Significance</p> <p>Functional design of the building. It allows the release of water from the verandah to outside. Water control in avoiding accumulation of water within the brick wall is an important management control of the brick architecture.</p>

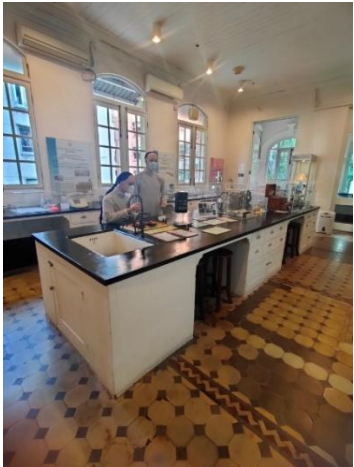
No.	Element	Character	Photo	Level of Significance
M-21	Laboratory at 1/F	<ul style="list-style-type: none"> -Long benches with teak tops ad fitted with sinks -Large centre tables fitted with sinks, drawers and cupboard -High ceiling -Large windows -Full height doors, double door leaves -Fireplace and associated compartments -Full height double doors, with louvered shutters and associated ironmongeries existing to verandah -White glazed wall tiles -Sinks with trademarks of London company

<p>Exceptional- Historical, Architectural and Social Significances</p> <p>BI is the only remained early- 20th Century bacteriological institute in Hong Kong with building form, layout, material highly intact. It witnesses the development of Hong Kong to become the sentinel post and centre of excellence that it is today in the surveillance of infectious diseases of global significance.</p> <p>The outfit of BI was constructed by Public Works Department. Most of the fitting believed to be the original design, original fitting or early replacements. Long bench laboratory tables are iconic laboratory design in 1900s. BI was where medical laboratory science began in Hong Kong.</p>

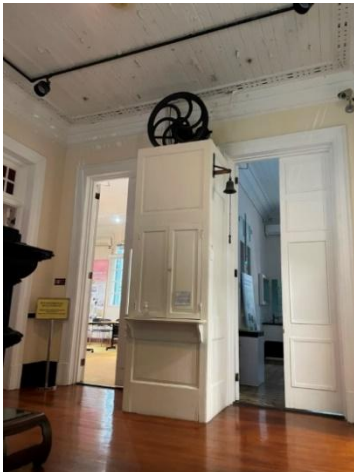
M-22	Dumb waiter system	<ul style="list-style-type: none"> -Channel (void) opening between 1/F and G/F -Dumb-waiter machine with the timber enclosure

<p>Moderate - Social Significance Low- Architectural Significance</p> <p>It showcases the design and daily operation of laboratories in transportation material and equipment around the three storeys.</p> <p>According to drawing record in 1994 prepared by Property Service Branch ArchSD, the size of the dumb-waiter was different from existing. Moreover, the part at the basement has already been demolished.</p> <p>Reconstructed can be considered because the furniture and service directly related to the laboratory's daily operation are limited (apart from laboratory furniture at 1/F). It would be a good display for visitors to visualize the old life of BI.</p>

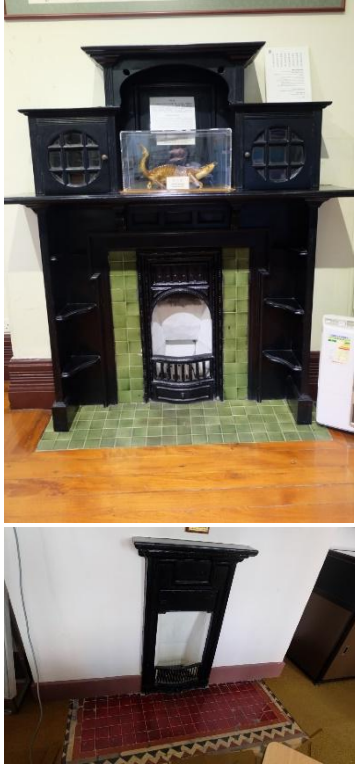
<p>M-23</p>	<p>Fireplaces at G/F and 1/F</p>	<ul style="list-style-type: none"> -Victorian style fireplaces -Additional shelving for ornaments above the mantelpiece -Timber mantel -Green and red glazed tile hearth and/or tiled surround -Timber surround -Steel grate -Steel ashpan

<p>High - Architectural Significance</p> <p>It showcases the architectural design of the Bacteriological Institute in the early 20th Century. It provides cross ventilation of the building through the chimney system and heat-up of rooms during winter time.</p> <p>Fireplace is one of the key features of the western architecture. It is a focus point of a room. It also showcases the living style of European bacteriologists at the far east. The Victoria style of the fireplace at the 1/F reflected the age of the building.</p> <p>There is no old record for the fireplaces. But they are believed to be located at the original locations connected to the chimneys at the roof. They are believed to be original or early replacement based on site evidence.</p>

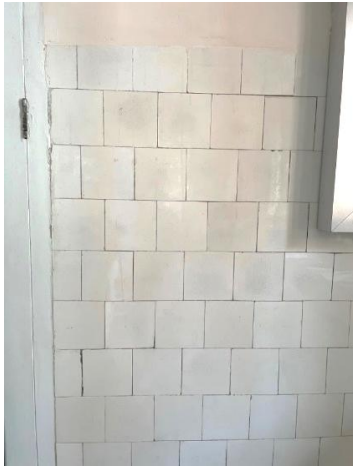
<p>M-24</p>	<p>White glazed wall tiles at 1/F laboratories</p>	<p>White glazed wall tiles</p>

<p>Moderate - Architectural Significance</p> <p>The outfit of the Bacteriological Institute in the early 20th Century was highly function. Basic glazed wall tiles in white colour at the laboratory for best hygienic control at the time believed to be original design.</p> <p>They showcase the architectural design of bacteriological laboratories in the early 20th Century.</p>
<p>M-25</p>	<p>Encaustic tiles in staggered pattern in the field with borders</p>	<ul style="list-style-type: none"> -Encaustic tiles -Plain red or black quarry are popular -Geometric pattern

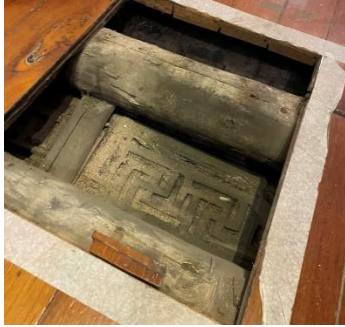
system for the internal rooms	between joists -Joist size

The structural frame of the building comprising timber joists supported by structural brick walls to the internal rooms. This structure demonstrates the structural beauty of the time. It is believed to be original.
M-28	Decorated plaster moulding ceiling	-Classical pattern -Located at the ceiling of main entrance hall

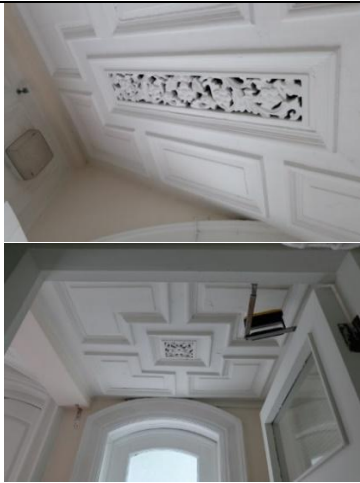
Moderate - Architectural Significance Mounded panels and fretwork are common decorations for western architecture. The decoration at BI is rather simple than the Victoria era. The ceiling panels and fretwork at the main entrance are the limited decoration of the BI. It is believed not the original after a hundred year of operation. They can be repaired and replaced on like-with-like basis if necessary.

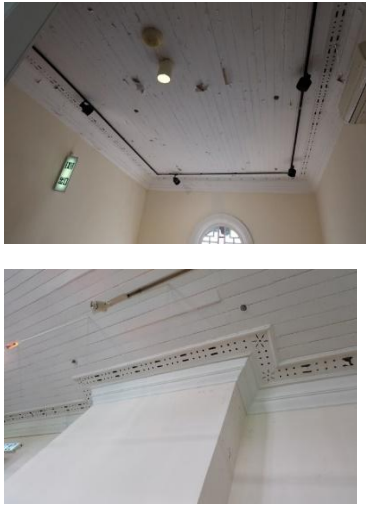
hundred year of operation. They can be replaced on like-with-like basis if necessary.
M-31	Timber fretwork and moulded cornice

<p>Low - Architectural Significance</p> <p>It serves both decorative and functional purposes. It can limit the accumulation /condensation water on ceiling. And allow better protection for the connections of different materials (e.g. wall and ceiling).</p> <p>The existing suspended ceiling fretworks are plywood and are believed not the original after a hundred year of operation. They can be replaced on like-with-like basis if necessary.</p>
M-32	Moulded timber skirting	Moulded timber skirting

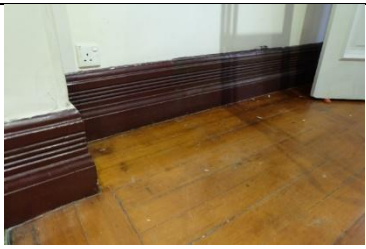
<p>Low - Architectural Significance</p> <p>Common feature of western architecture. It serves both decorative and functional purposes. It can protect the lower wall from normal activity damage and allow better protection for the connections of different materials (e.g. wall and floor).</p>

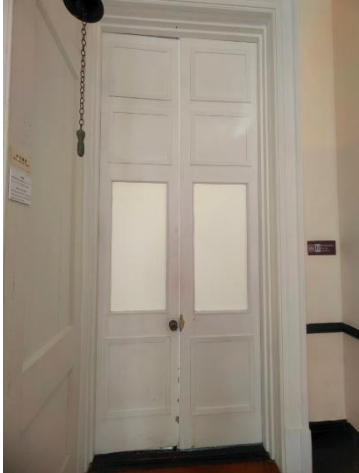
M-36	Internal door to laboratories at G/F and 1/F	<ul style="list-style-type: none"> -Full height door opening -Moulded timber architraves -Double door -180-degree open inward

<p>Moderate - Architectural Significance</p> <p>Large doors allow better ventilation and sufficient sunlight for the bacteriological laboratory. It showcases the wisdom of architectural design of BI of adaptation of English architecture for sub-tropical climate.</p> <p>According to the public works report year 1905, all doors to the laboratories were double- layer doors. One with mosquito-proof wire gauze is believed to have been removed when mosquito controls no longer necessary.</p>
		<ul style="list-style-type: none"> - Timber door ironmongeries including metal door lock, handle and door stay 		<p>Low - Architectural Significance</p> <p>It is believed most of the timber doors and ironmongeries may not be the original after a hundred year of operation. They may not even the original style of use. They can be repaired and replaced on like-with-like basis if necessary and no other proof for the original design.</p>

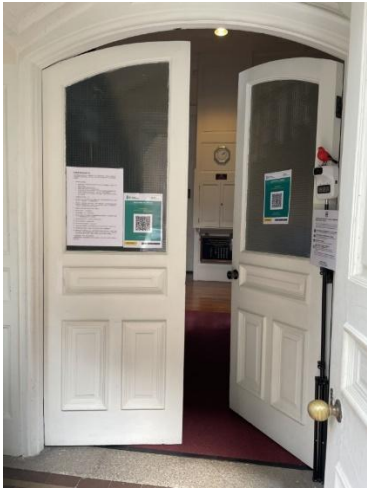
M-37	Door after main entrance door	<ul style="list-style-type: none"> -Moulded timber architraves -Door opening -Allow 180-degree open inward

<p>Moderate - Architectural Significance</p> <p>Doorway to create a semi-space before directly entering the main space (G/F and 1/F) from external area.</p> <p>The existing door and ironmongeries may not be the original after a hundred year of operation. They can be repaired and replaced on like-with-like basis if necessary.</p>
		<ul style="list-style-type: none"> - Double leaf timber door - Ironmongeries including metal door lock, handle and door stay

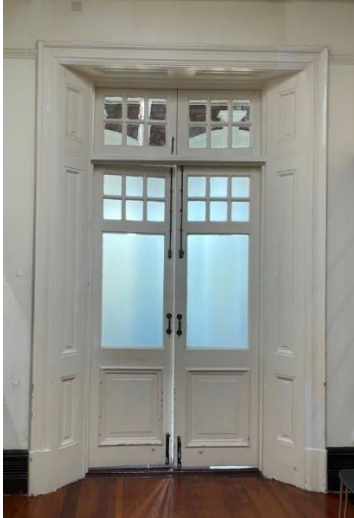
<p>M-38</p>	<p>Double door</p>	<ul style="list-style-type: none"> -Moulded timber architraves -Full height door and fanlight opening -Allow 180-degree open outward to verandah

<p>Moderate - Architectural Significance</p> <p>The existing door and ironmongeries may not be the original after a hundred year of operation. They can be repaired and replaced on like-with-like basis if necessary.</p>

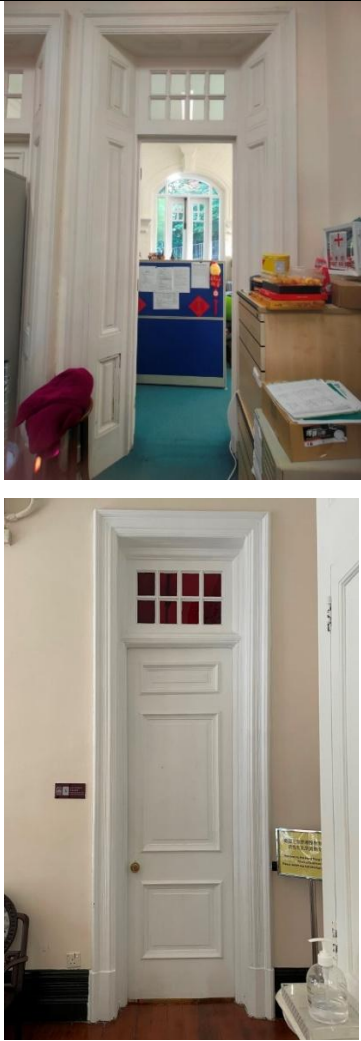
<p>M-39</p>	<p>Internal full height single door with fanlight</p>	<p>-Moulded timber architraves -Full height door and fanlight opening</p>

<p>Low - Architectural Significance</p> <p>The existing door and ironmongeries may not be the original after a hundred year of operation. They may not even be the original style of use. They can be repaired and replaced on like-with-like basis if necessary and no other proof for the original design.</p>
<p>M-40</p>	<p>Internal full height double door</p>	<p>-Moulded timber architraves -Full height double door opening</p>

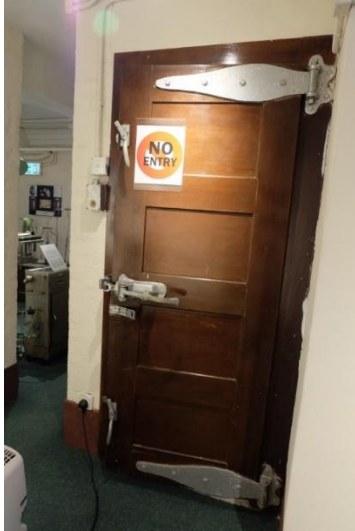
<p>M-41</p>	<p>Door for autopsy room at B/F</p>	<p>Door opening and the associated ironmongeries to the autopsy room at B/F</p>

<p>Moderate - Architectural and Social Significance</p> <p>BI is the only remained early- 20th Century- built bacteriological institute in Hong Kong. Autopsy is important for providing first -hand information of a infectious disease. This would be good evidence on demonstration of process of bacteriological research.</p> <p>As there is no record of the room and no mention of the autopsy room in the 1905 record, this room is believed to be later construction.</p>
<p>M-42</p>	<p>Segmental arch openings at B/F</p>	<p>Segmental arch</p>
