Conservation Management Plan
for
Hong Kong Museum of Medical Sciences
at No. 2 Caine Lane, Mid-Levels,
Sheung Wan, Hong Kong.

By Spence Robinson Limited

Oct 2024

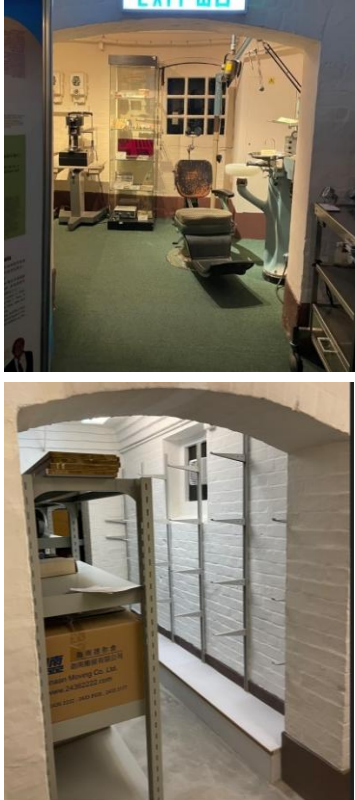
<p>Moderate - Architectural and Social Significance</p> <p>BI is the only remained early- 20th Century- built bacteriological institute in Hong Kong. Autopsy is important for providing first -hand information of a infectious disease. This would be good evidence on demonstration of process of bacteriological research.</p> <p>As there is no record of the room and no mention of the autopsy room in the 1905 record, this room is believed to be later construction.</p>
<p>M-42</p>	<p>Segmental arch openings at B/F</p>	<p>Segmental arch</p>

<p>Moderate - Architectural Significance</p> <p>Segmental arch is a common features of western architecture that reflects the truthfulness of the brick building structure.</p>
<p>M-43</p>	<p>King-post timber trusses</p>	<p>King-post timber trusses with steel fixings</p>

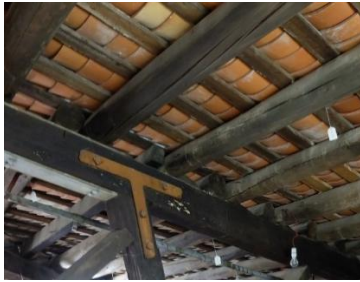
<p>High- Architectural Significance</p> <p>They stand on the timber trusses and cover by Chinese double-pan-double roll tiles as a complete roof system. This showcases the adaptation of English colonial building with local climate and culture. They work well to avoid water leakage of pitched tiled roof.</p>
M-45	Timber plywood ceiling - with brick catwalk	Timber plywood ceiling -with brick catwalk

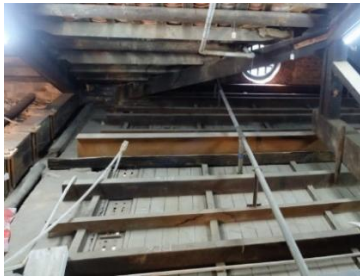
<p>Moderate - Architectural Significance</p> <p>Enclosed roof with plywood grid ceiling allows decorative moulded design of the internal ceiling. It is common for English architecture. Catwalk allows regular maintenance and access to the roof top.</p>

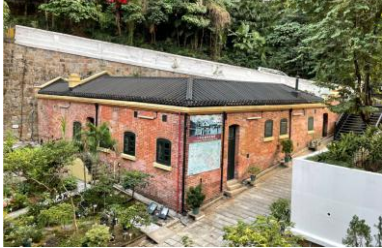
No.	Element	Character	Photo	Level of Significance
SQ-1	Red brick external wall	-Flemish bond red brick -Red brick appearance

<p>Moderate –Architectural Significance</p> <p>Exposed bricks were used instead of rendered surface. It is the true expressed of material in Art and Crafts movement.</p> <p>The different colour and shape of the Flemish bond red bricks and mortar joints show that the brick walls have undergone many time of repair works and no proof any part of the external brick wall is original. The arrangement (layout) of the structural brick walls should be low intact and much of the original.</p>
SQ-2	Double-pan-double-roll pitched roof with Wu-yin	-Pitched roof -Chinese Double-pan-double-roll roof system with use of wu-yin

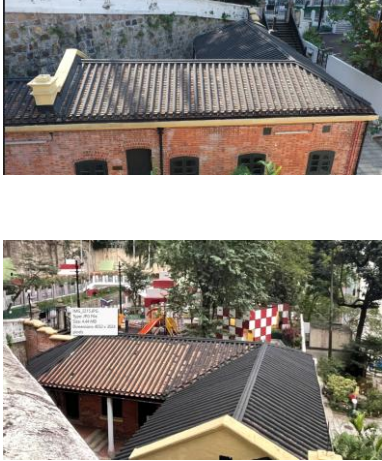
<p>Moderate – Architectural Significance</p> <p>The western pitched roof in use of Chinese double-pan-double-roll tiles system and wu-yin, that showcase the adaption of Western architecture with local material, craftsmanship for adaptation of local climate and culture in colonial style building.</p>

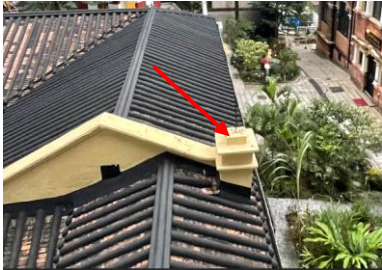
SQ-3	Chimney stack	Chimney stack

<p>Moderate – Architectural Significance</p> <p>Only the upper part of the chimney remains and the lower part is unknown. It may not be connected to the fireplace as the is very small.</p>

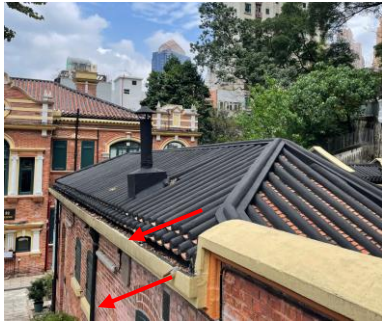
<p>Moderate – Architectural Significance</p> <p>It is believed the gutter and downpipe drainage system is the original which (gutter) is found in the old photo.</p> <p>Some downpipes are believed to be original location, and some are later addition which were not found in the early photos. The later additional may consider remove to retain a clearer facade.</p>
SQ-5	Ventilation windows on external wall	-Small ventilation windows at high level -Metal guard

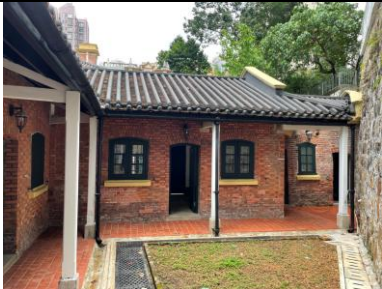
SQ-6	Central courtyard	Central courtyard

<p>Moderate - Architectural Significance</p> <p>There is no record on the courtyard of the Staff Quarters. It is guessed that it could be used for hanging laundry for Asian staffs.</p>
SQ-7	Cover walkway under pitched roof	Cover walkway under pitched roof

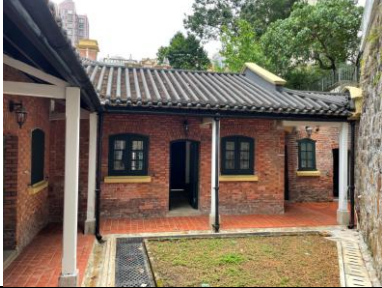
<p>Moderate - Architectural Significance</p> <p>It is functional for staffs to move around the rooms at the rain reasons. It also creates extra semi-open space for users other than functional rooms.</p>
SQ-8	Doors	-Segmental arch over door -Door opening

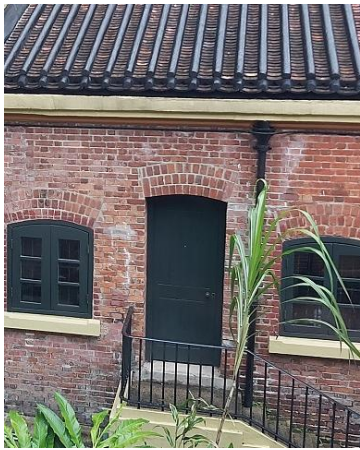
Moderate - Architectural Significance
		-Timber door -Timber door frame -Ironmongeries		<p>The size and the location should be the original or early intervention and should be retained as far as possible.</p> <p>Low - Architectural Significance</p> <p>The existing door and ironmongeries may not be the original after a hundred year of operation. They can be repaired and replaced on like-with-like based if necessary.</p>

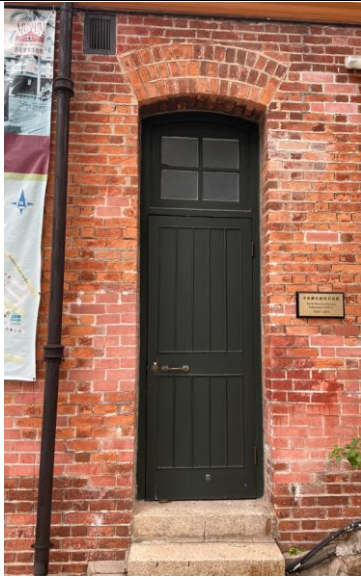
Main entrance door

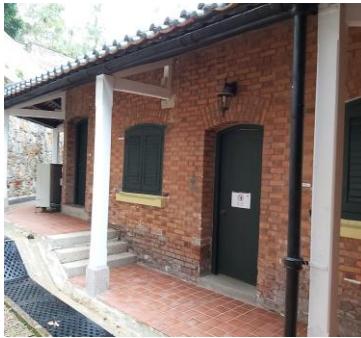
<p>Side door</p>

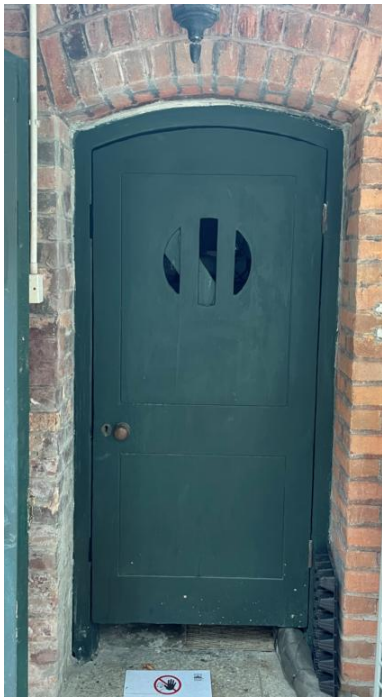
<p>Doors at the back</p>

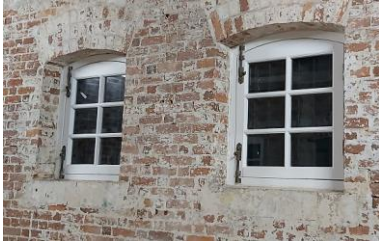
<p>Low - Architectural Significance</p> <p>The existing window and ironmongeries may not be the original after a hundred year of operation. They can be repaired and replaced on like-with-like based if necessary.</p>
	<p>North west facing façade with louvered shutter</p>

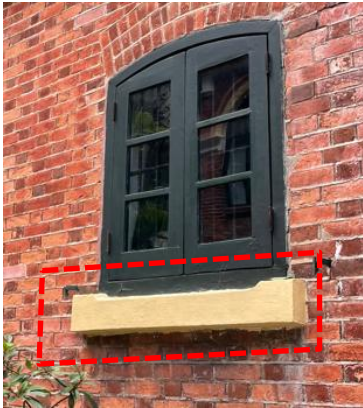
<p>U shape window sill</p>

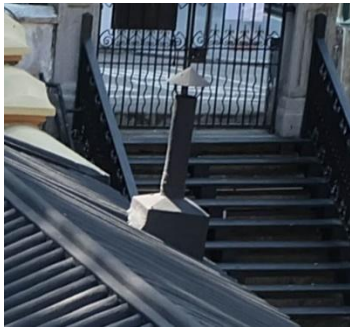
SQ-10	Cast iron chimney	-Location -Cast iron chimney -For release of smoke

Moderate - Architectural Significance The location and function is believed to be original as it connects to the brick grove at the kitchen for the release of smoke at the tiny enclosed space. However, whether this is the original type of kitchen chimney is unknown as it is very different from other brick chimney of the BI compound and another chimney stack at the rooftop of the Staff Quarters.
SQ-11	Overhang roof supporting system	-Column and truss -Stone on wall for support of the truss

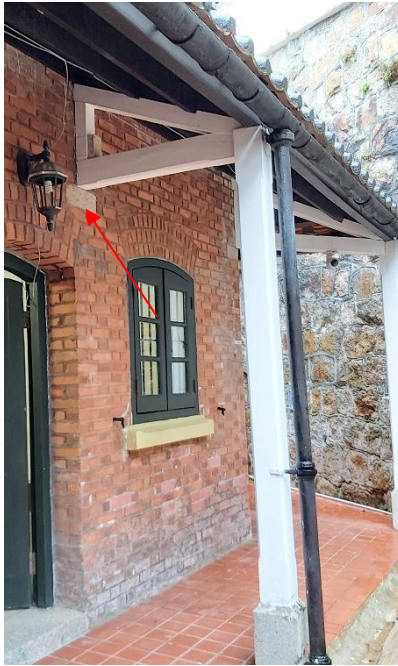
Moderate - Architectural Significance It is a typical supporting element of the pitched roof. The location and system should be the original. But the concrete column and timber truss should be later replacement. They can be repaired and replaced on like-with-like based if necessary.

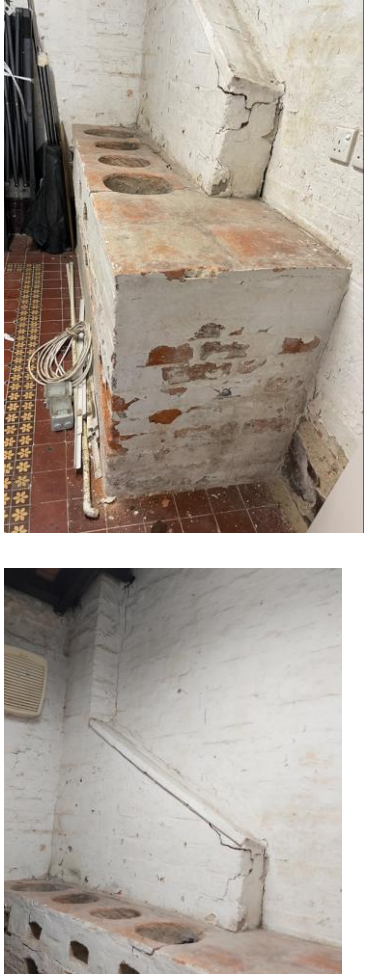
No.	Element	Character	Photo	Level of Significance
SQ-12	Brick grove with stack	Brick grove with connected brick stack

<p>High – Historical, Social and Architectural Significance</p> <p>It is the only remaining elements at the Staff Quarters that can proof the functional use of the building and the room (kitchen).</p> <p>It is the living evidence of the first Bacteriological Institute in Southeast Asia with Staffs' Quarter that had once housed 11 staffs.</p>
SQ-13	Encaustic tiles at the kitchen and new toilet room	Encaustic tiles

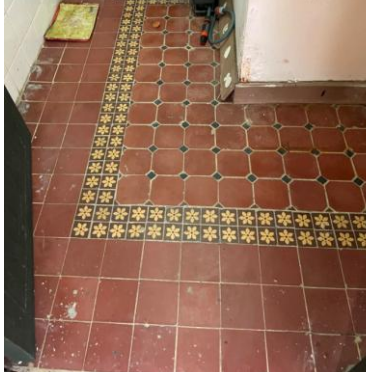
<p>Low - Architectural Significance</p> <p>No record for the original type of tiles. They are believed to be later replacement and can be repaired and replaced on like-with-like basis.</p>

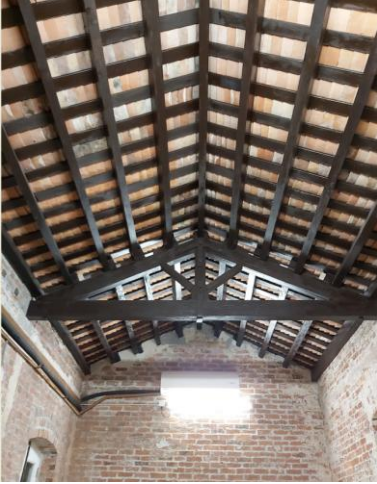
<p>SQ-14</p>	<p>Truss system</p>	<p>King post timber truss</p>

<p>High - Architectural Significance</p> <p>They showcase the wisdom and outstanding craftsmanship at the time with true material (timber) but not mass production.</p>
<p>SQ-15</p>	<p>Purlin-batten and tile roof supporting system</p>	<p>-Timber purlin -Timber batten -double-pan-double-roll tiled layering system</p>

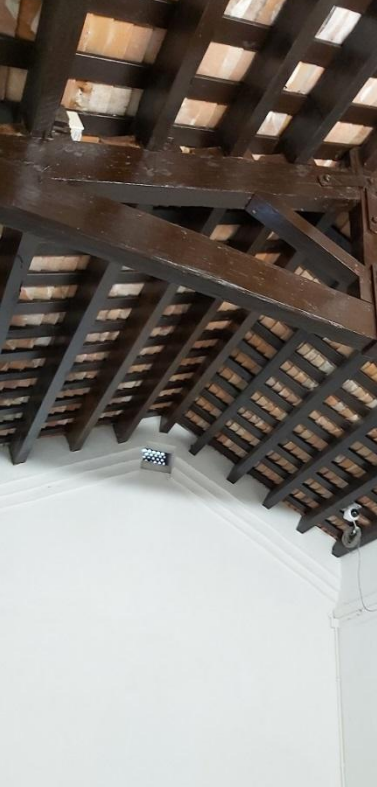
<p>High - Architectural Significance</p> <p>They showcase the wisdom and outstanding craftsmanship at the time with true material (timber) but not mass production.</p>

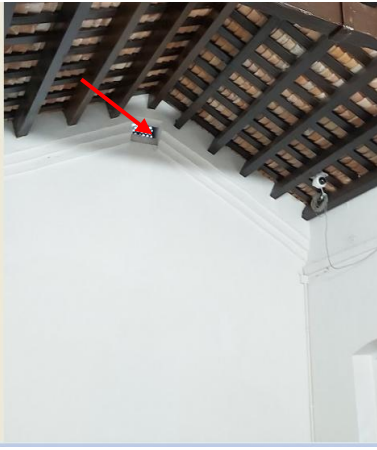
<p>SQ-16</p>	<p>Wall decorative moulding</p>	<p>Wall decorative moulding</p>

<p>Low - Architectural Significance</p> <p>It serves both decorative and functional purposes. It can limit the leakage/condensation water on wall and allow better protection for the connections of different material (e.g. wall and ceiling).</p>
<p>SQ-17</p>	<p>Layout</p>	<p>-Layout -Arrangement of rooms</p>

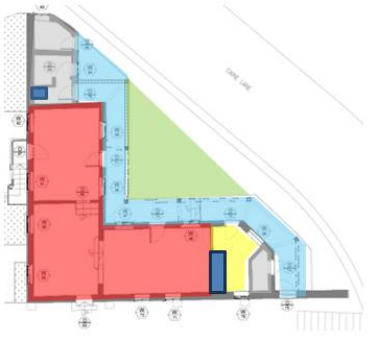
<p> Bedrooms for accommodation of 11 Chinese attendants Kitchen Covered walkway Courtyard <u>Store room</u> or other use </p>	<p>High- Historical, Architectural and Social Significance</p> <p>According to written records and site evidence (wall, window and door openings), it is believed that the overall layout of Staff Quarters remains largely intact since built. It is the living evidence of the architecture design and daily life of the first bacteriological institute in Asia.</p>
