HONG KONG CEMETERY

CONSERVATION MANAGEMENT GUIDELINES

PART I – BUILT AND NATURAL HERITAGE

By Property Conservation Company Limited in association with Cinotech Consultants Limited and Ir. A J Cooper

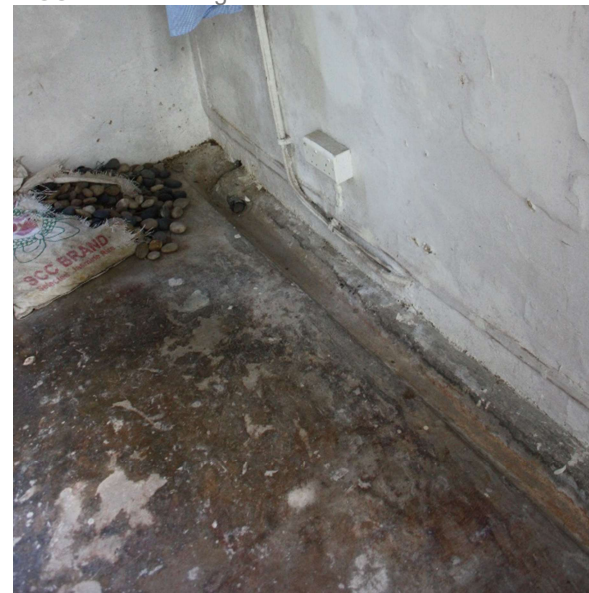
FIGURE 4-23 Drains at the edge of the cement floor

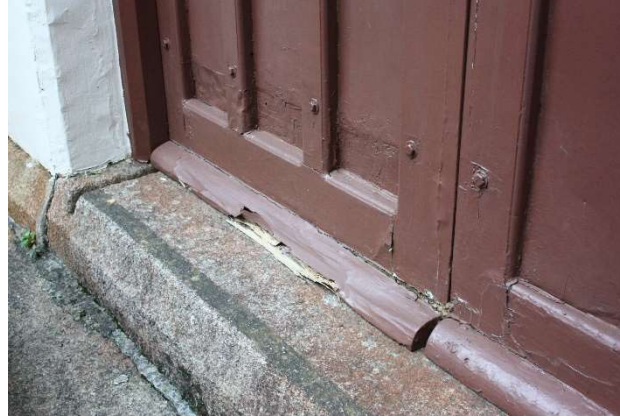
- 4.1.22. Despite the close attention of the FEHD management and maintenance officers, the building is deteriorating from lack of careful and timely attention, for example, vegetation roots are growing inside the walls. Although regular painting may hide superficial problems, the fundamental issues have not yet been addressed, such as termite damage and rising damp. Also, the adjoining toilet block and an external water stand pipe, cause serious damp ingress through the original external wall, which worsens the overall dampness within the building and consideration should be given to its demolition. During the preparing of this guidelines, signs of termites damage was visible to the doors.

FIGURE 4-25 Timber door with signs of termite at the wooden cill

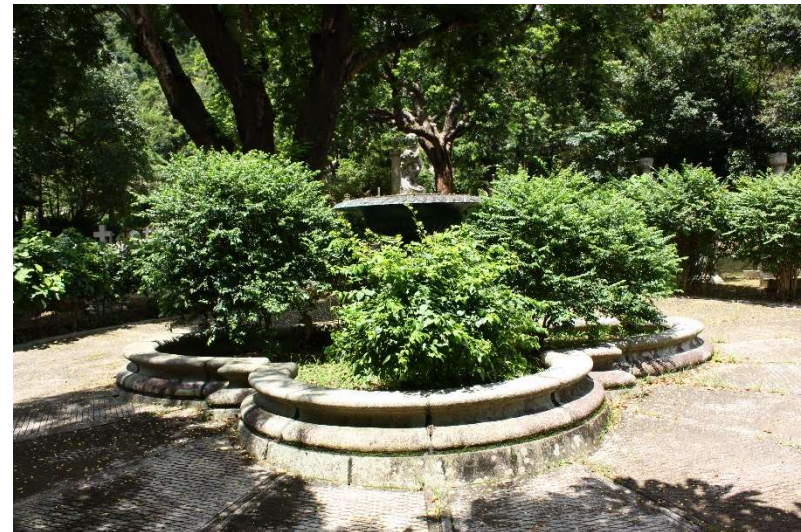
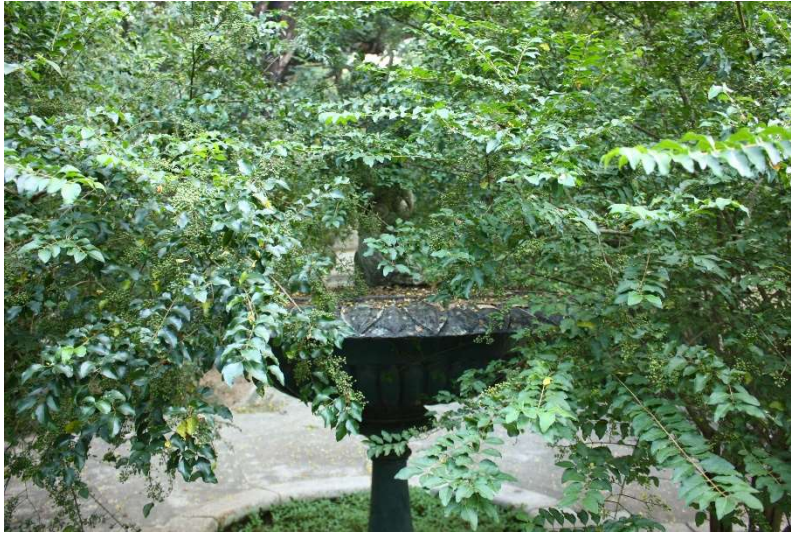
- 4.3.5. But, it is no longer able to function as a fountain due to water supply defects. Photos from 2012 (Figure 4-37) and 2016 (Figure 4-38) show the fast rate of growth of the shrubs which now obscure the historic feature.

FIGURE 4-38 Fountain in November 2016 (Property Conservation)

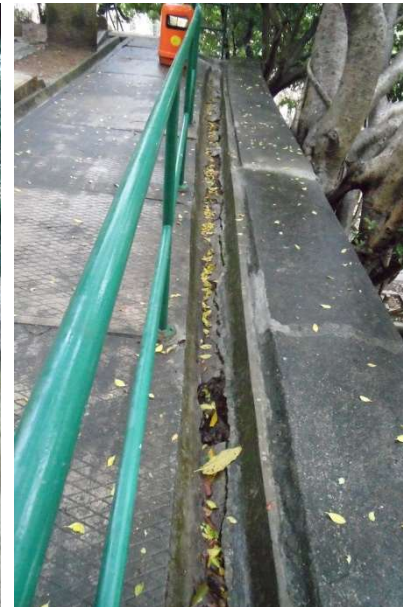
5.3.13. Many of the drainage channels are in poor condition (Figure 5-6 and Figure 5-7). They have deteriorated further in the last year. Broken channels let water into the soil and increase the likelihood of failure. Some appear to have been constructed using a very thin layer of mortar. They should be repaired as soon as possible.

FIGURE 5-6 Channel in Jan 2016

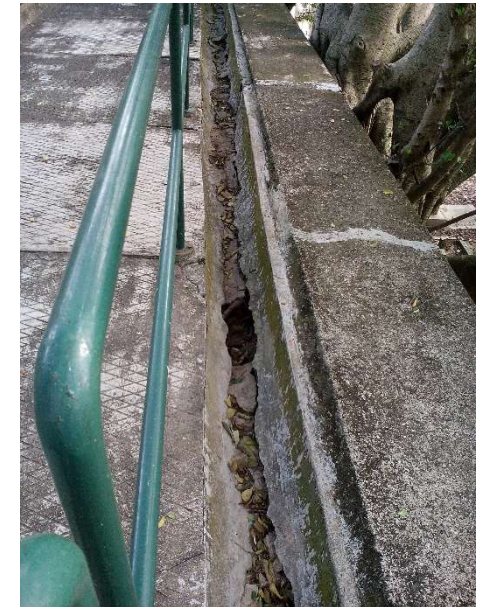
FIGURE 5-7 Channel in Dec 2016

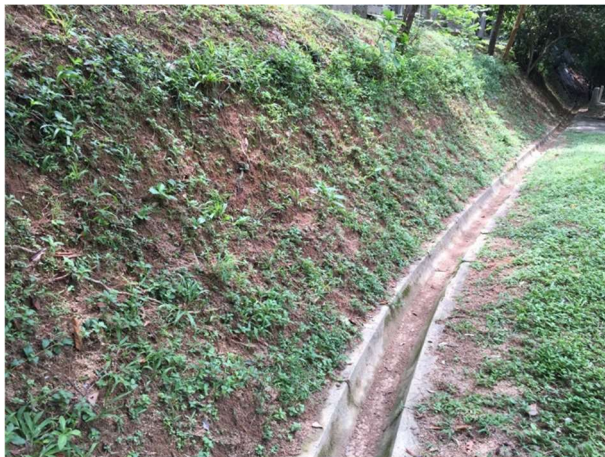
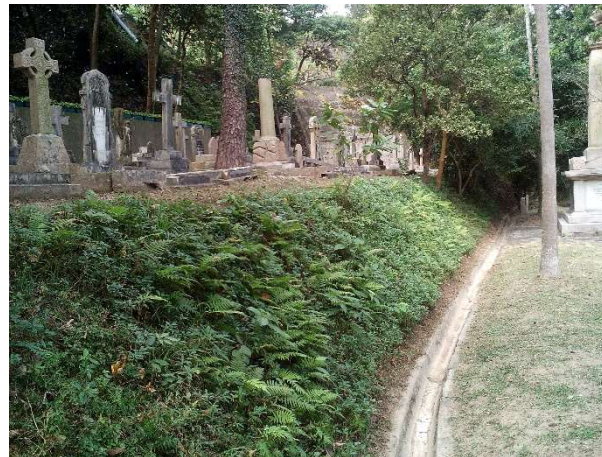
- 5.4.1. This feature is a vegetated cut slope with a maximum height of 3.2m and a length of about 54m. It is L-shaped on plan, with the longer leg being about 40m long. The slope angle varies, with a maximum slope of approximately 60° above it.
- 5.4.2. During visits in January and March 2016, it was noted that the vegetation had been trimmed very short and some erosion was observed. However, following concerned group's efforts to persuade FEHD not to trim the vegetation so diligently, the vegetation has grown to a reasonable cover, at least on the slope (Figure 5-8).
- 5.4.3. Provided that the vegetation is allowed to flourish, with only careful trimming, no work should be necessary on this slope.

FIGURE 5-8 Before and After Views

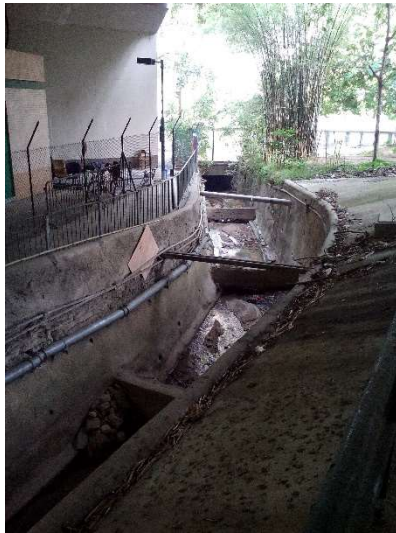
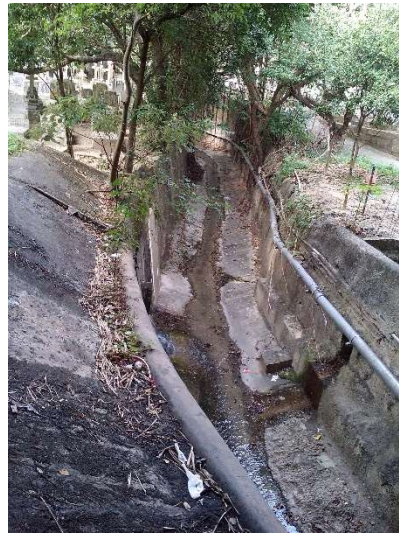
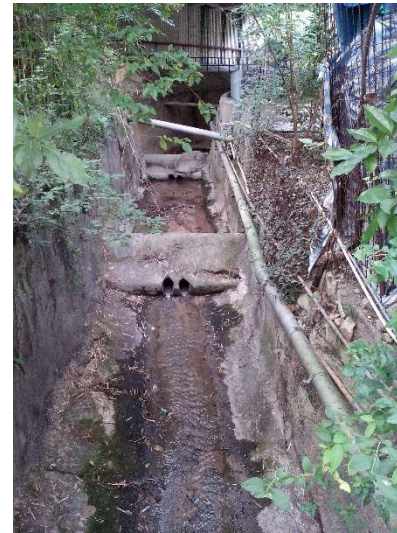
- 5.4.4. These features are both about 3.3m high walls, which form the sides of a sizeable drainage channel with flow control weirs at intervals (Figure 5-9). Maintenance responsibility for these walls should perhaps lie with Drainage Services Department (DSD) rather than Architectural Services Department (ArchSD).
- 5.4.5. In the Stage 2 Study Reports, both of the walls are described as being dry-packed random rubble walls with pointing in places, but photos in the reports show shotcrete on the walls, indicating that upgrading has been undertaken at some time.
- 5.4.6. No immediate action is required apart from trimming vegetation where tree roots might cause local deformation of the walls.

FIGURE 5-9 Views of the Walls

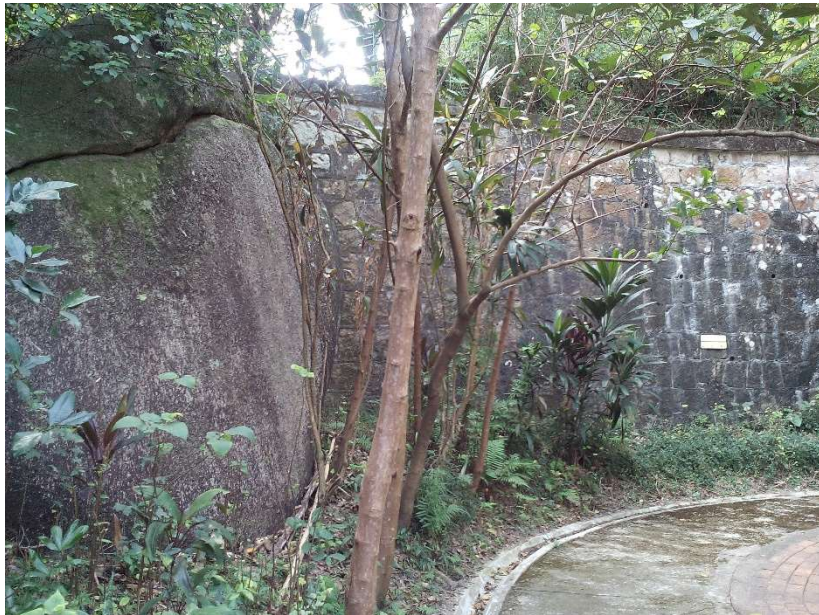
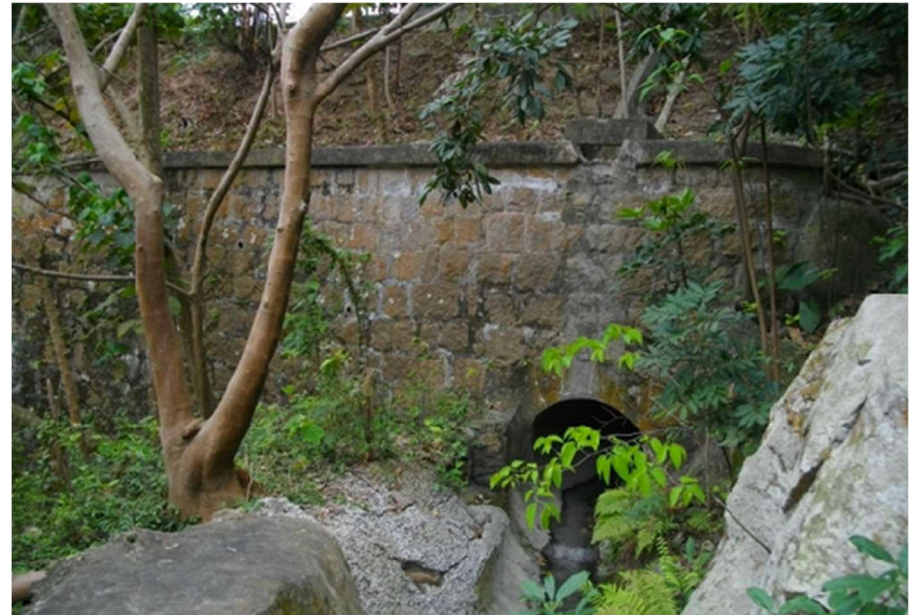
- 5.4.7. This feature is a 4.9 m high dressed block wall, with a 30° vegetated cut slope above it. The slope is approximately 2.5m high. Figure 5-10 is a photo from the Stage 1 Report in the SIS.
- 5.4.8. An unusual feature of this slope/wall is a large stepped channel on the slope, which empties into a vertical pipe and exits through a large arched opening at the base of the wall into another drainage channel. Judging by the appearance of blocks on the face, this arrangement was probably added well after the construction of the wall but before 1996, when the inspection visit for the Stage 1 Report was made.
- 5.4.9. The Stage 1 Report notes minor displacement of blocks near the crest at the east end and cracked and missing pointing at many locations, as well as a full height crack at the centre. This is not evident now, so maintenance work has probably been carried out.

FIGURE 5-10 Wall and Slope CR 1995 Showing Drainage Feature

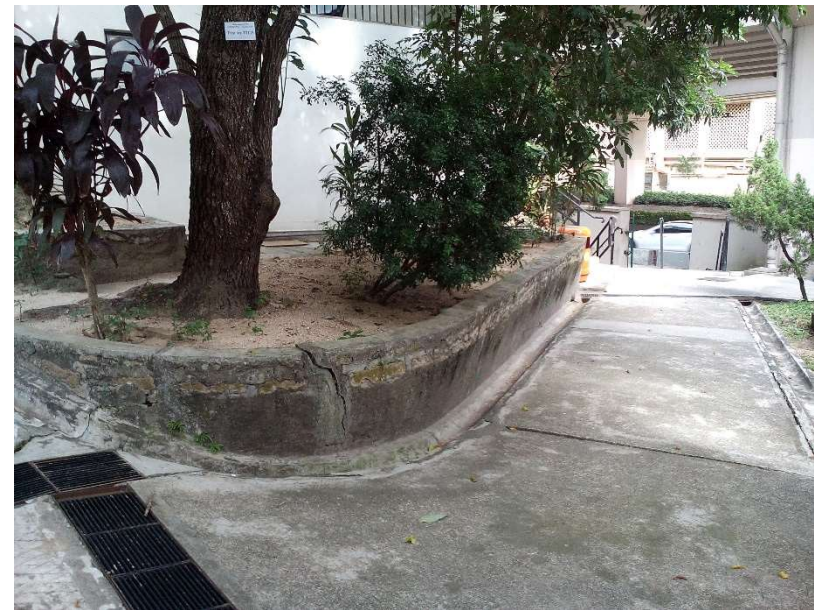
FIGURE 5-12

- 5.4.12. The second feature is a low wall, less than 1m high, supporting a planter containing one large tree and a younger one (Figure 5-12). It shows significant signs of distress, possibly due to tree root growth, and is in danger of collapse. Remedial action is overdue.

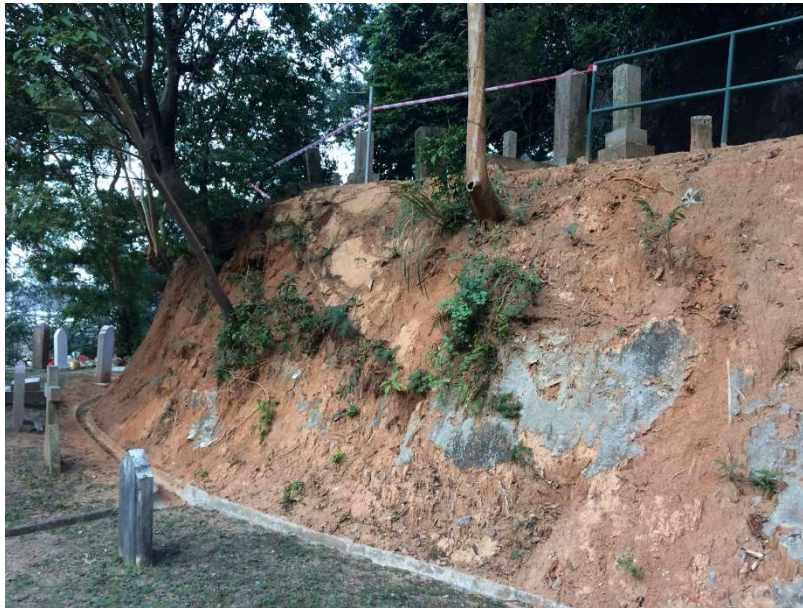
FIGURE 5-13 View of Slope

- 5.5.1. This slope is a cut slope about 5m high and 80m long, with a face angle of about 60°. It is outside of the study area but is included because fireflies have been seen in the vicinity.
- 5.5.2. According to the Stage 1 Study, it was covered entirely in shotcrete but this has recently been removed as part of “maintenance work” by ArchSD (Figure 5-13). Some vegetation had managed to take root on the face.
- 5.5.3. The channel at the crest is in good condition.

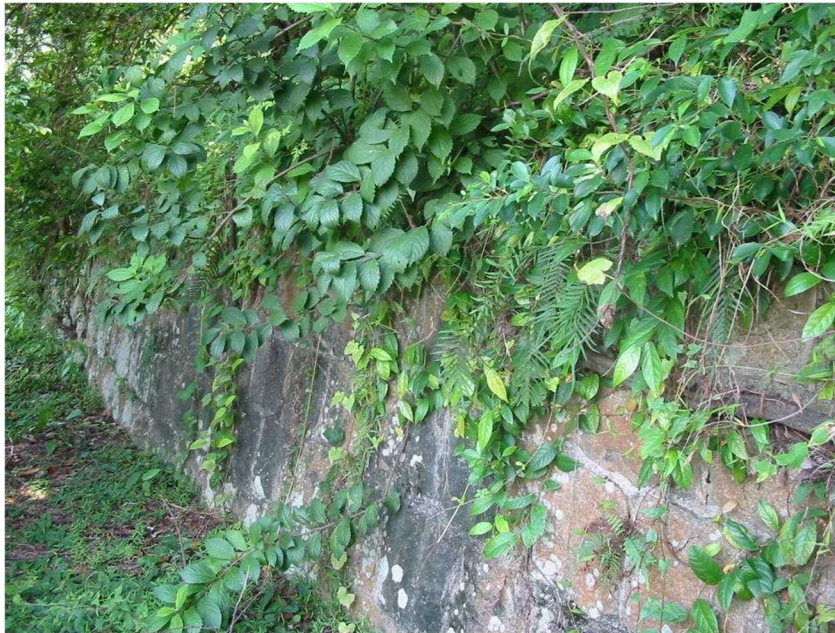
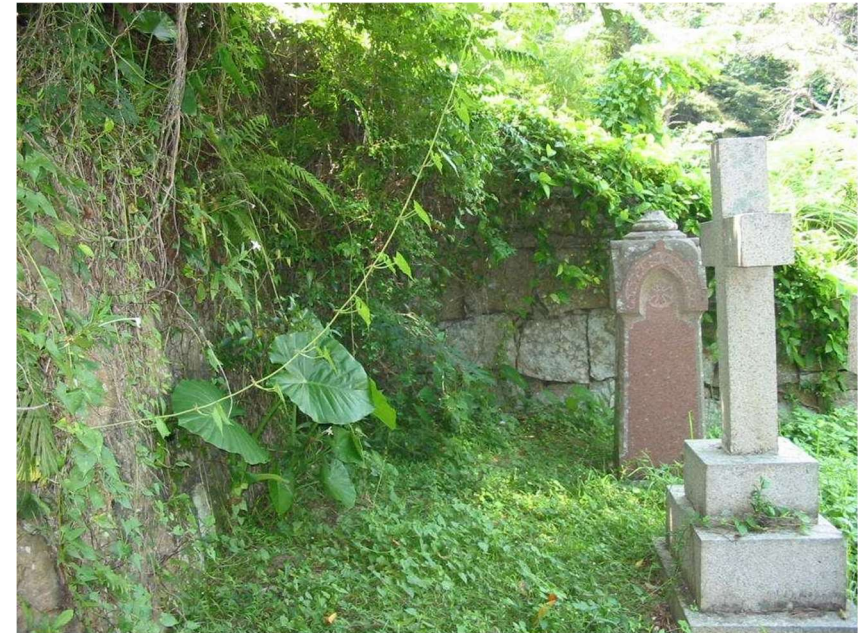
FIGURE 5-14 Views of Wall

- 5.5.4. This feature is a wall about 30m long and 1.8m high with a slope above of about 1.6m height and 40° slope angle. The slope is mostly vegetated (Figure 5-14). At its southern end it abuts feature 11SW-D/CR2227 (see next section). At the northern end it continues as the side wall of a staircase but that part is not include in the feature as shown in the SIS.
- 5.5.5. Some repointing of the wall has been carried out. Less severe cutting back of vegetation is now evident and this will help prevent erosion of the slope.
- 5.5.6. No action is required to ensure stability.

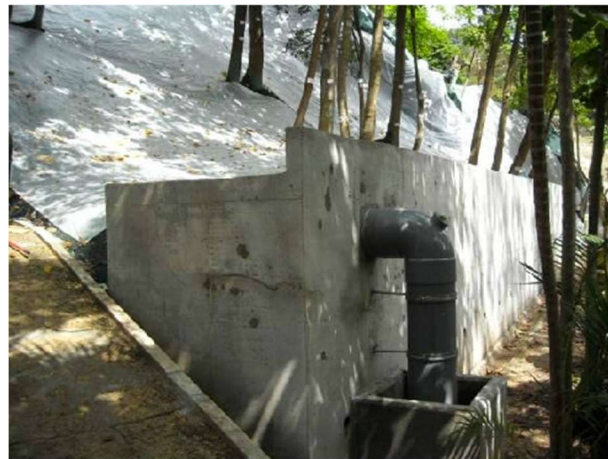
FIGURE 5-15 Upgraded Wall

- 5.5.7. This feature was upgraded in 2015 and is included as a prime example of poor design. It is a new concrete wall 2m high, with a slope above it, about 12m high and 50° average slope angle. The wall is 17m long but the slope is about 45m in length. The upgraded concrete retaining wall and cut slope above it are shown in Figure 5-15.

- 5.5.11. The wall could have been designed to be more in keeping with the environment and the subsequent attempt to improve the look of the wall has been less than successful. The upstand at the front serves no useful purpose and the channel behind it, which feeds into a plastic drainage pipe at the south end, could easily have been placed within the wall rather than on the exterior where it is an eyesore (compare with the drainage arrangement in wall 11SW-D CR 1995 above). A stone facing would have helped it blend the wall in with older walls on the site.

- 5.5.14. The wall upstand should be removed and the downpipe at its southern end should be replaced with a pipe within the wall. The wall should be faced with stone to match nearby walls.

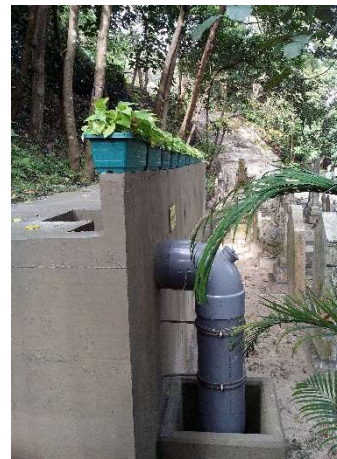
FIGURE 5-16 'Improved' Wall

- 5.5.9. I understand that concerned group had asked for improvements to the aesthetics; the result was that the wall was painted khaki and some green plastic planters were placed on top of the wall, though these later disintegrated. They have now been replaced and filled with soil and some plants are growing (Figure 5-16).

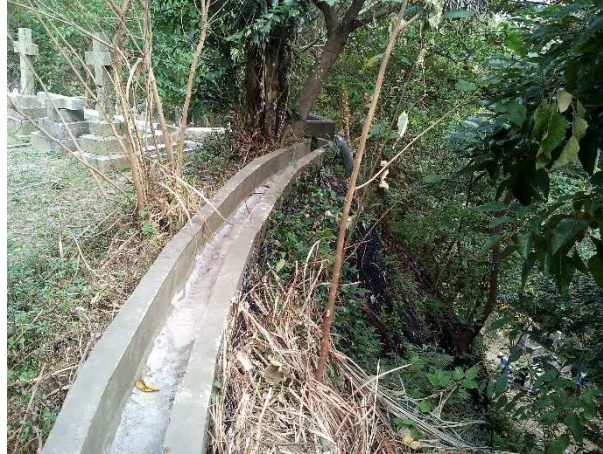
FIGURE 5-17 Crest Channel

- 5.5.10. At the top of the slope is a new crest channel (Figure 5-17) connecting to a catch pit and a down pipe (Figure 5-18). As the ground level of the platform behind the crest is about 1m below the level of the channel, the channel cannot fulfil its intended purpose of collecting runoff from the platform during heavy rain.

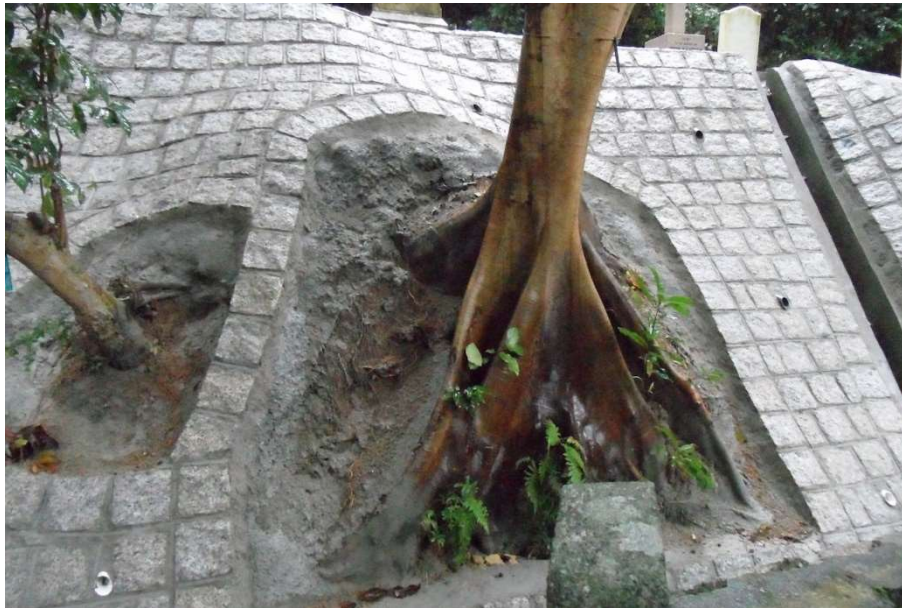
FIGURE 5-21 Slope After Upgrading

- 5.5.22. The *Detail Information* in the Stage 1 Report states that the slope is a 3.6m high, 75° vegetated cut slope. The slope is approximately 2.5m high, cover is 40% vegetated, and 60% chunam but it has recently been upgraded (see Figure 5-21). The shape of the new granite block facing suggests that the upgrading followed a failure in the slope.

- 5.5.24. Whilst the granite facing blocks have a more pleasing appearance than shotcrete, and complement the surrounding environment, the treatment of the tree rings needs attention. The finishing of the base where it meets the drainage channel is poor in places.

- 5.5.23. It appears that the slope was shotcreted before placing of the granite facing blocks and the shotcrete has covered most of the soil within the tree rings and even the tree trunks. This should be removed, otherwise the trees may die.

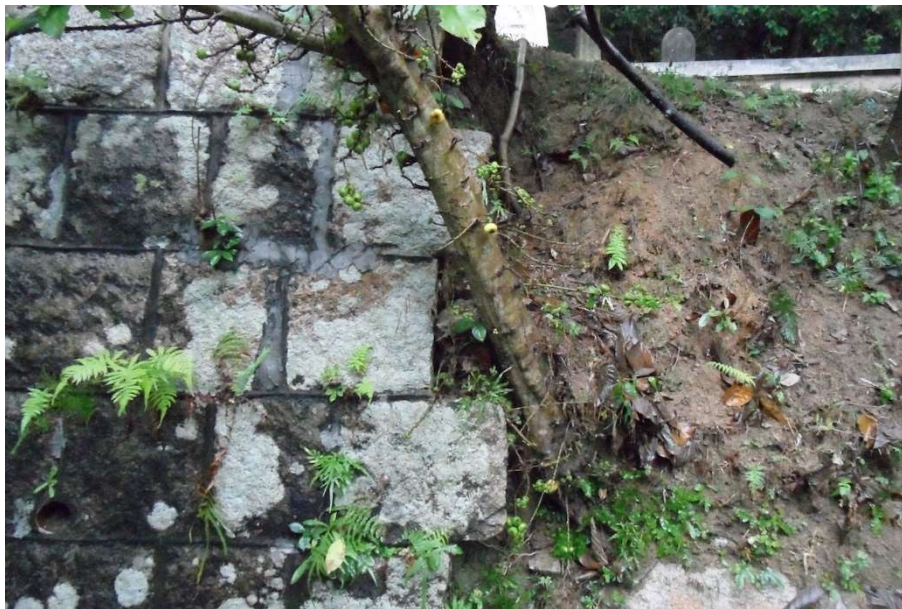
- 5.5.25. The *Detail Information* in the SIS states that slope is a 3.6m high, 75° cut slope. It also states that the slope is 80% vegetated, 10% bare and 10% chunam. However, the Stage 1 Report states that the slope has square rubble facing.
- 5.5.26. The slope is at the left of the upgraded section and is partly a bare slope and partly a masonry wall or facing (see Figure 5-22). It is unfortunate that it was not upgraded at the same time as 11SW-D C2146.
- 5.5.27. It is obvious that individual blocks in the masonry wall or facing have moved, opening up the joints in the masonry. These have been repointed (badly). The end of the wall or facing has not been treated at all.
- 5.5.28. If no action is taken, it is likely that erosion of the soil will lead to progressive failure of the wall blocks.

FIGURE 5-22 Cut Slope 11SW-D C 2148 Showing Wall and Soil Junction

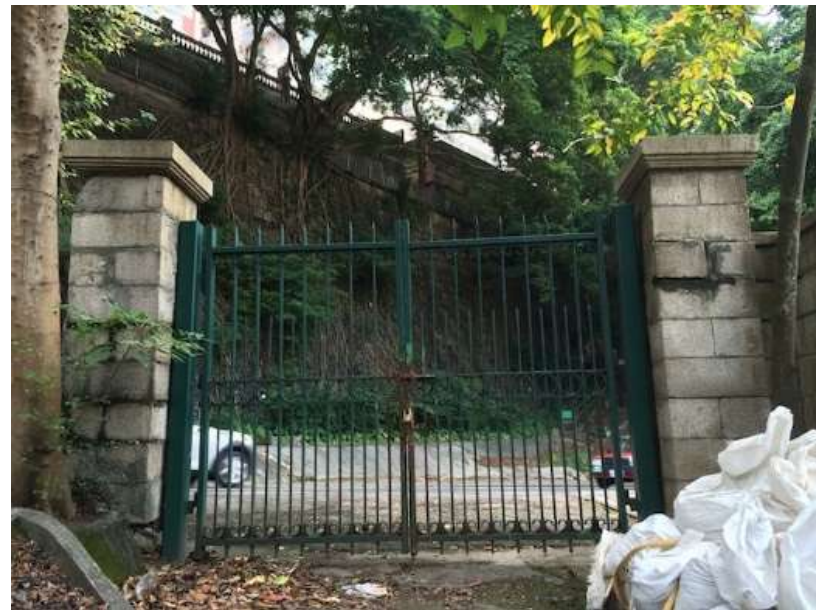
6.2.1. There is another entrance to the Cemetery on Stubbs Road; however, that entrance is locked by a gate. The metal gate has two masonry posts and it appeared that the gate has been kept the same for many years. When compared with the historic gate in 1946-1947 at the main entrance (Figure 6 3), the entrance at Stubbs Road is of similar style. Although the profile of the metal gate cannot be traced, the masonry posts were intact.

FIGURE 6-4 Entrance gate at Stubbs Road (Luc Carson)

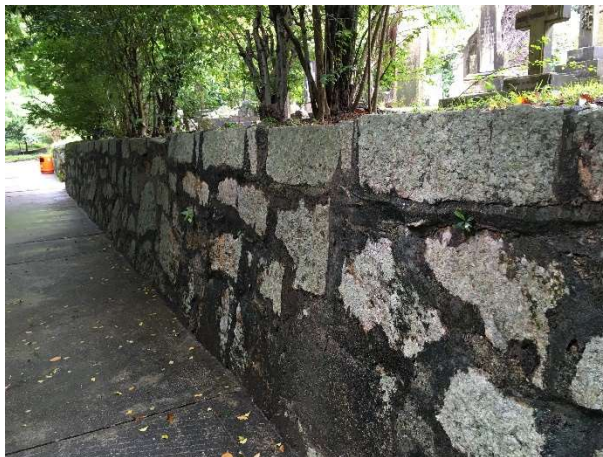
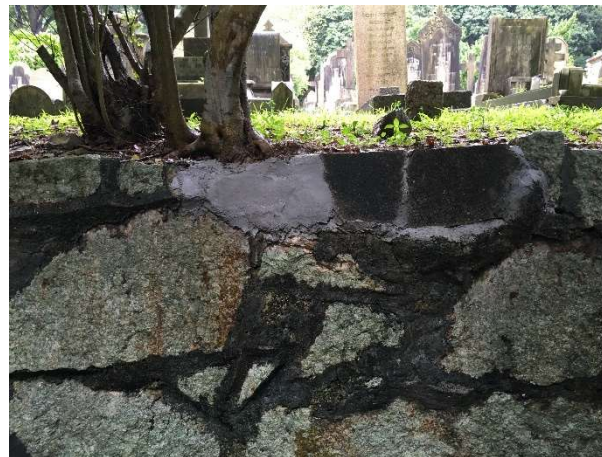
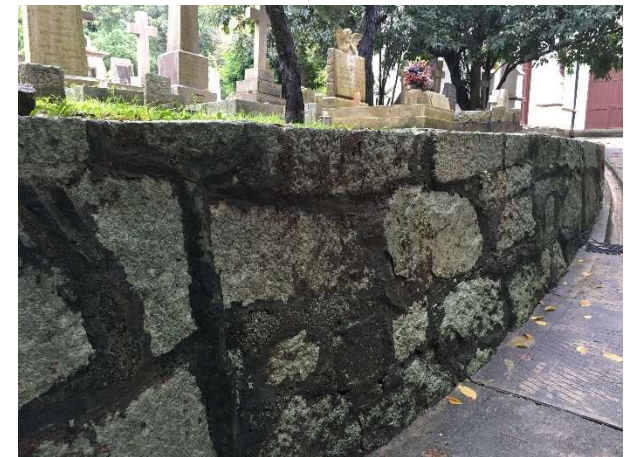
Retaining wall

6.2.3. There are retaining wall near to the Chapel, which was built by masonry of irregular shape, it is believed to be a historic retaining wall which dated back to the early days. It forms along one of the main path connecting the Chapel and the fountain. However, due to its height of only about 1-1.5 meter, it seems that the strength and stability of it has not been taken care of. Besides, it is found that cement patches were used to fill in the gaps, it does not match with the historic stones and affect the aesthetic value of it.

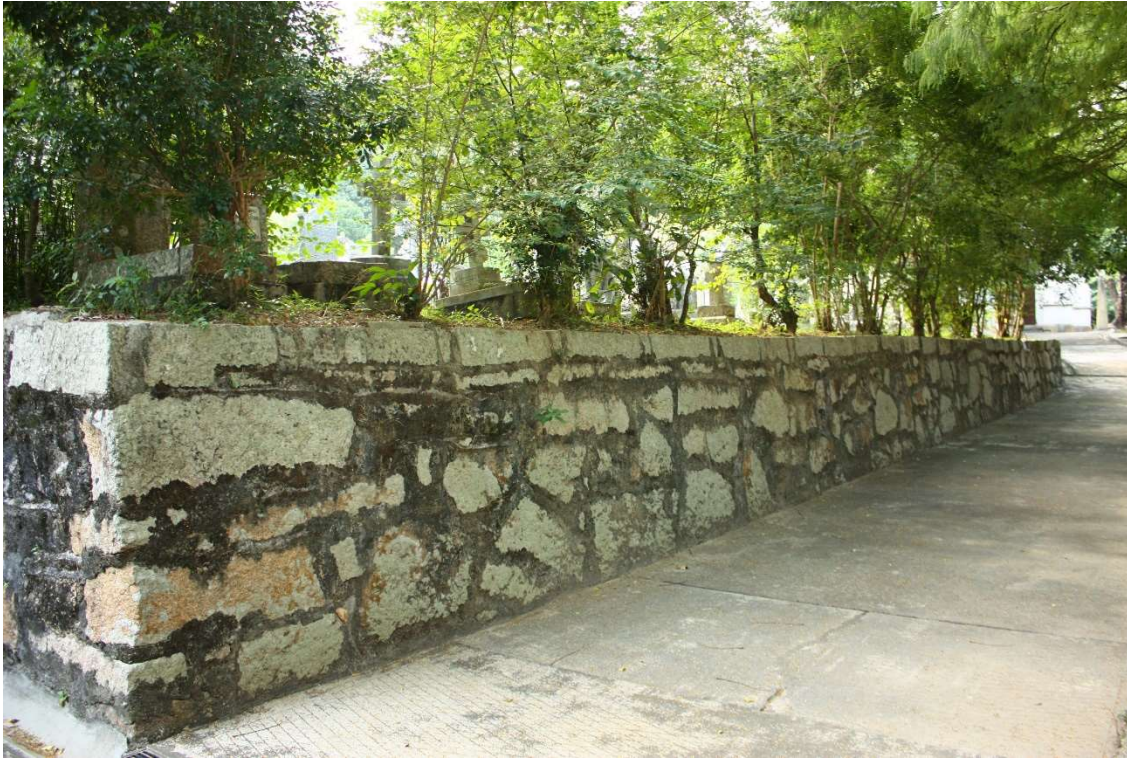
Steps

- 6.2.4. There is a flight of stairs leading to the fountain and behind it, there is a few steps leading to the Monument. The steps are granite stones and the steps are painted yellow at the edge to alert the visitors. The steps leading to the Monument looks unstable, it may be caused by the roots by the big tree next to it.
- 6.2.5. This axis and steps were seen from the historic plan in 1922 and these were probably designed to lead from the entrance when the Cemetery was remodeled in the end of the 19th Century. These records the historic layout of the Cemetery and are important to the historic landscape.

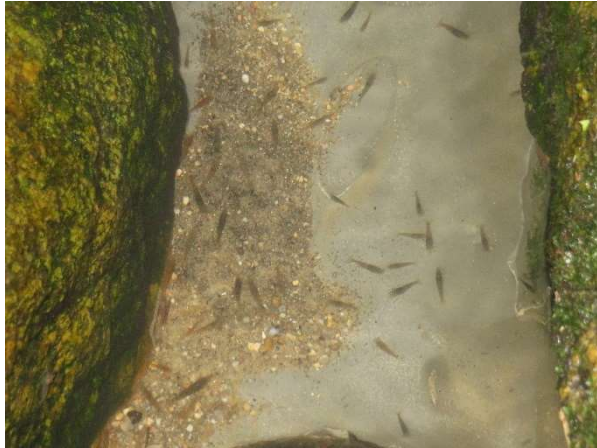
- 8.3.1. Two streams in the southern part of the cemetery are short in length and semi-natural. The upstream section is cut off by Stubbs Road and the water flows across the road by concrete channels. Odour was detected from the upstream water, suggesting that the water may have been polluted before entering the cemetery area. Downstream section is also channelized to increase flow rate for draining purpose.

Freshwater fauna cannot survive in bare concrete environment and may get washed away. Without a clean natural habitat in different stream sections, the stream in the cemetery is not expected to support high fauna such as fish and amphibians. This was reflected by inhabitation of large numbers of small shrimps found to be the most successful fauna in the stream (photo below), which were observed during the surveys.

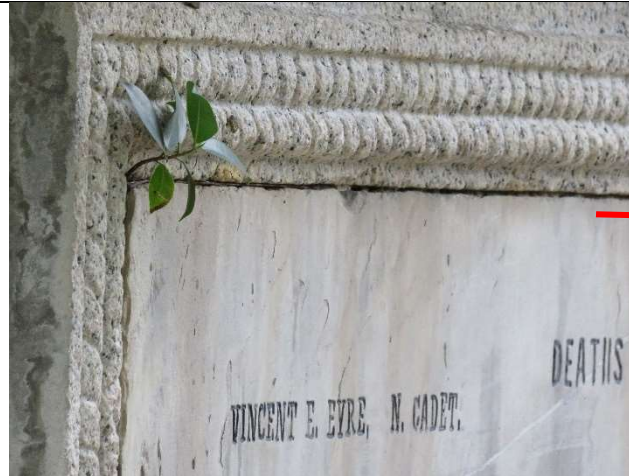
Aggressive growth of Ficus species

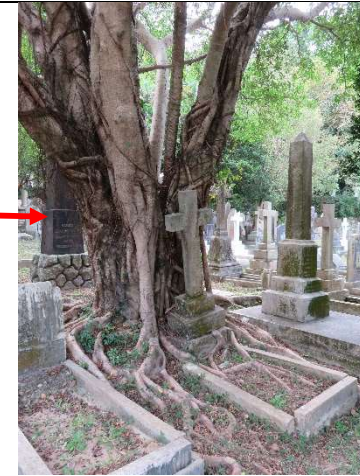
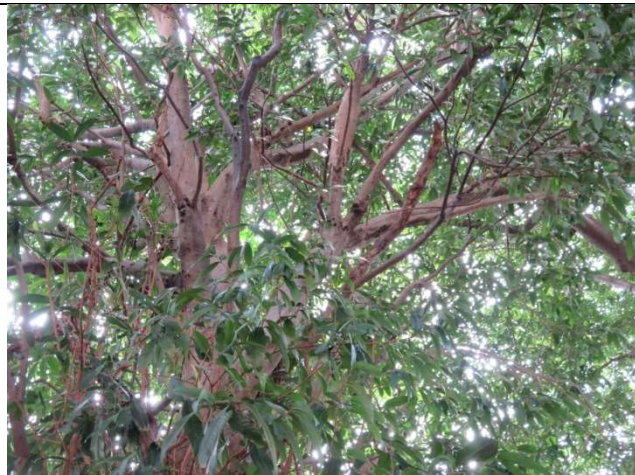
Pruning of dead branches required

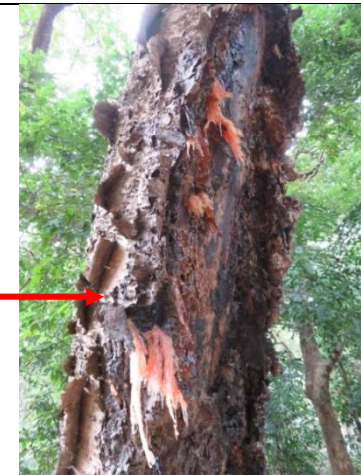
Dead tree with leaked sap, growing next to footpath

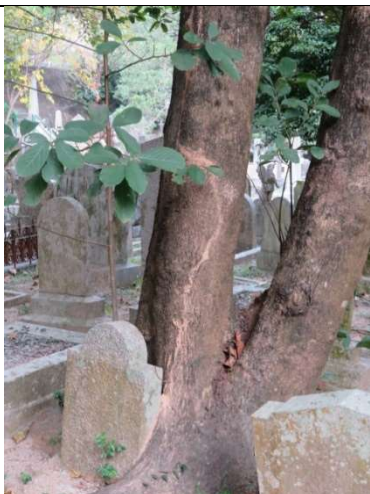
Sign of termite infection

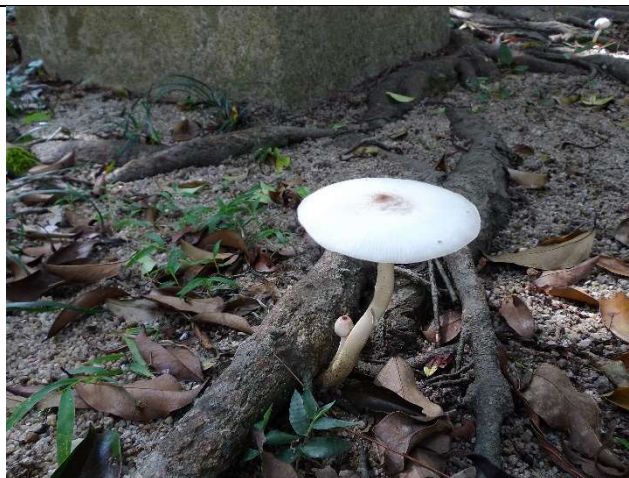
Fungal infection

- Decorative trimming or pruning shall be in line with the natural landscape and historic character;
- Identify diseased trees (e.g. severe wood decay and fungal infection) and provide treatment at early stage to increase chance of recovery;
- Minimize mowing near woodland edge to allow natural regeneration of native plants;

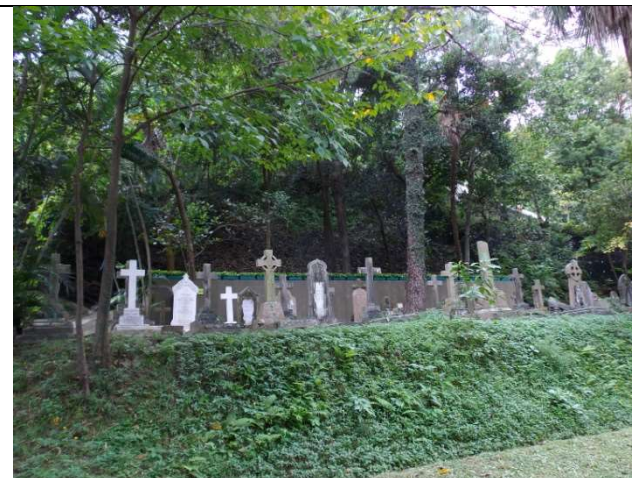
Wall behind the graves can be decorated with vertical greening

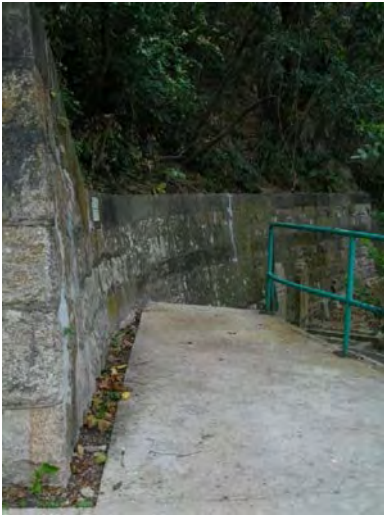
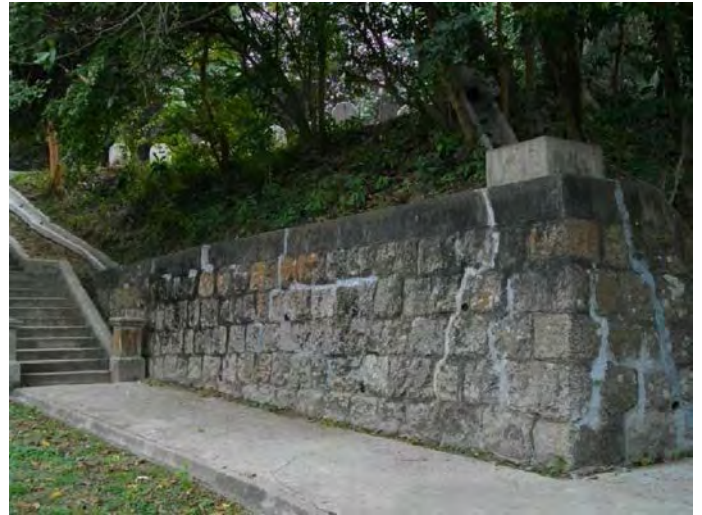
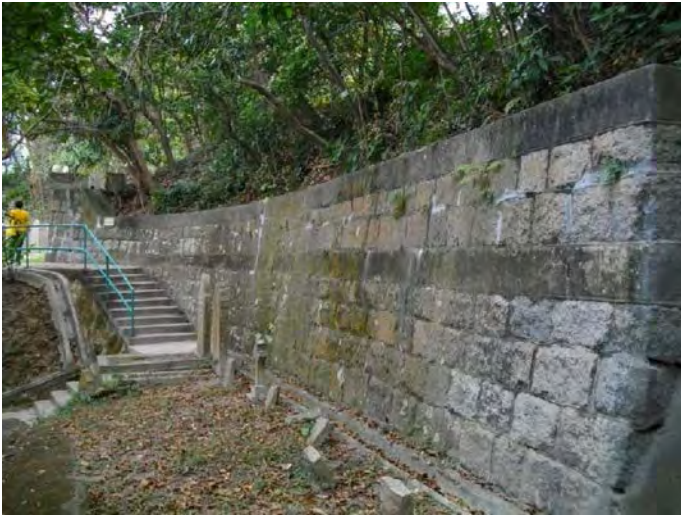
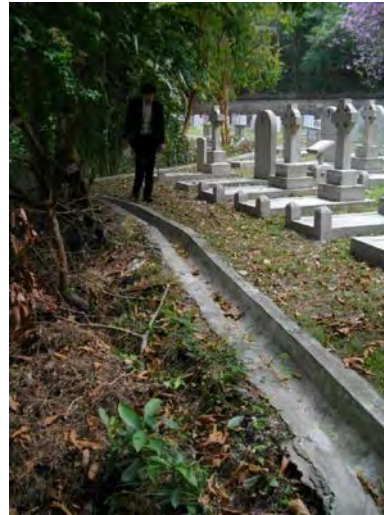
PHOTO

Sign of Seepage:	Slope: No signs of seepage Wall: Signs of seepage
Criterion A satisfied:	N
Sign of Distress:	Slope: Minor (near crest, mid-portion) Wall: Moderate (near crest, mid-portion, at toe)
Criterion D satisfied:	N
Non-routine maintenance required:	N
Note:	N/A
Masonry wall/Masonry facing:	Y
Note:	DRESSED BLOCK FAIR CONDITION. BUT EROSION BEHIND WALL AT NORTH REVEALS LOOSE RUBBLE BEHIND.
Consequence category (for critical section):	3
Observations:	N/A
Emergency Action Required:	N
Action By:	N/A

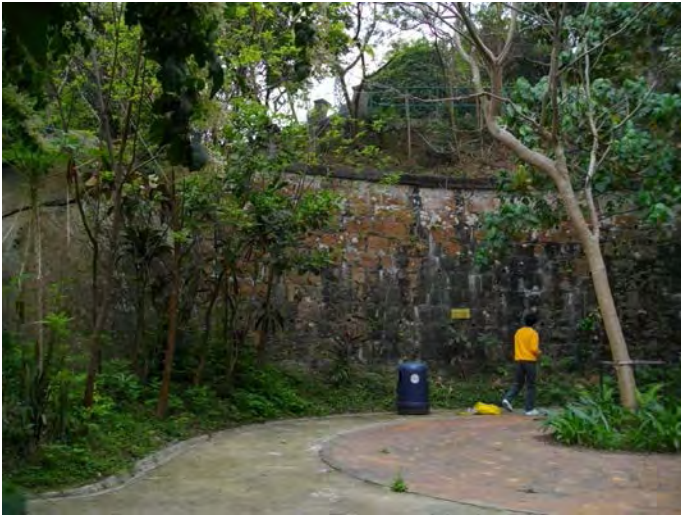
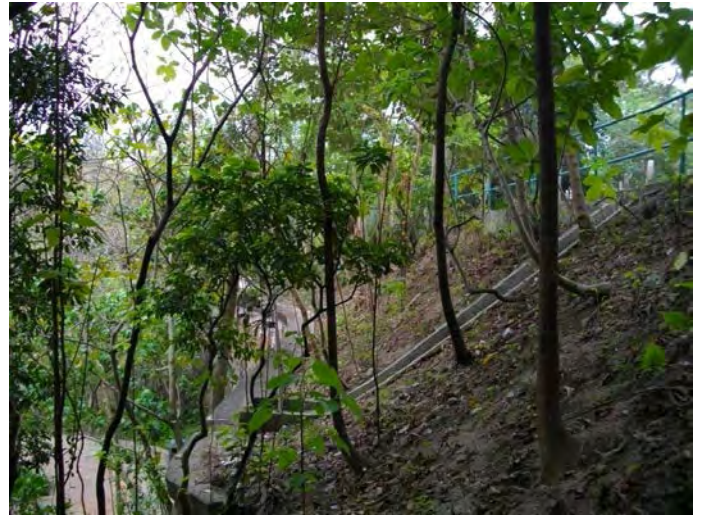
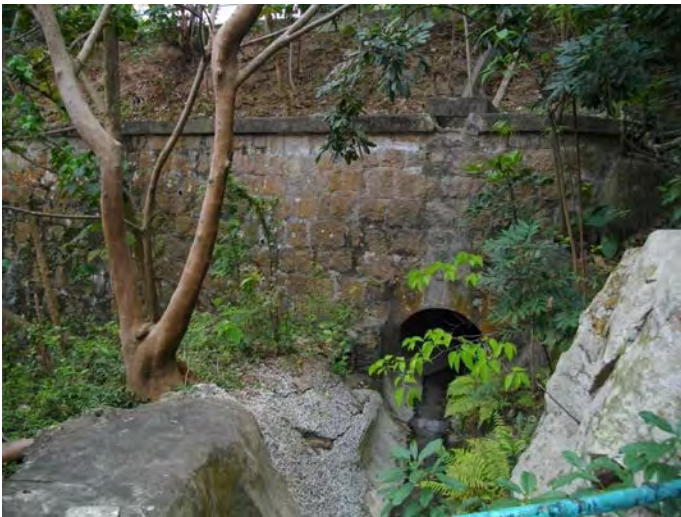
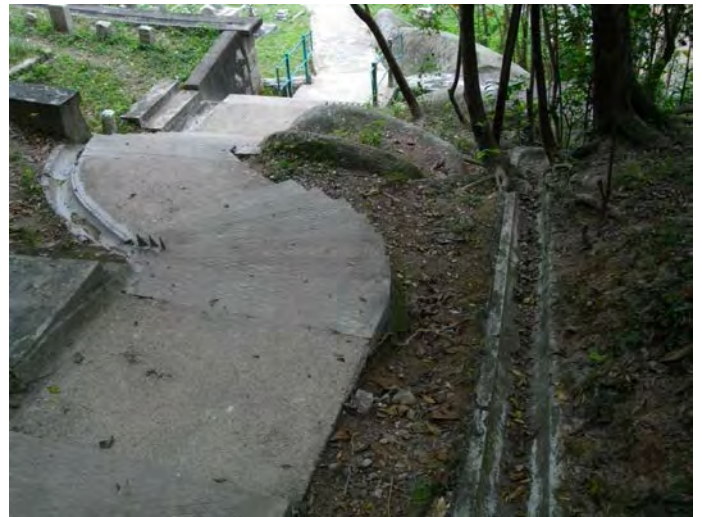
Sign of Seepage:	Slope: No signs of seepage Wall: Signs of seepage
Criterion A satisfied:	N
Sign of Distress:	Slope: Minor (near crest, mid-portion, at toe) Wall: Moderate (near crest)
Criterion D satisfied:	N
Non-routine maintenance required:	N
Note:	N/A
Masonry wall/Masonry facing:	Y
Note:	Minor displacement of blocks near crest at east end. Cracking and missing pointing at many locations full height crack at centre.
Consequence category (for critical section):	3
Observations:	N/A
Emergency Action Required:	N
Action By:	N/A

Check / repair Services:	Y
Action By:	DSD
Non-routine Maintenance:	N
Action By:	N/A
